Jeff & Susan Wicks,  
Parker Lane, R.D.2,  
PUKEKOHE. 2677.

Ph/Fax : 09 2390123  
Mob- Jeff : 0274 469909  
Mob- Susan: 0274 469039

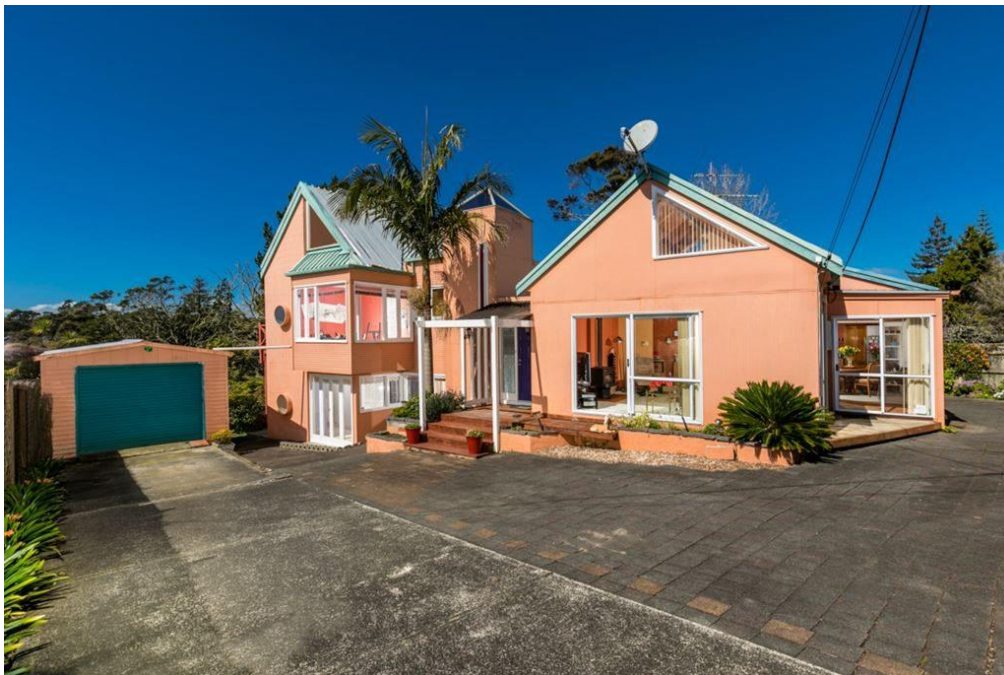
The subject house was probably originally built in the late 1960's to early 1970's. It was then extended in the mid to late 1970's & then again around 1985. It is an unusual quirky sort of a house. The second owner, who apparently was an architect, added the NE wing with the stairwell etc. & the porthole windows.

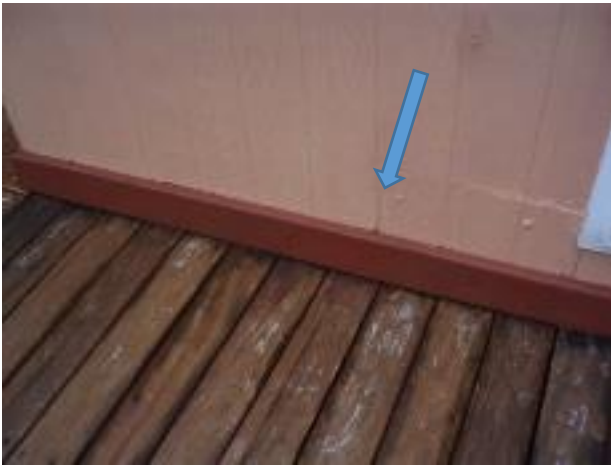
1. This is the North elevation to the RHS of the front door. This horizontal timber baton at the base level serves to trap moisture between the baton & the fibrolite cladding. See note 1.

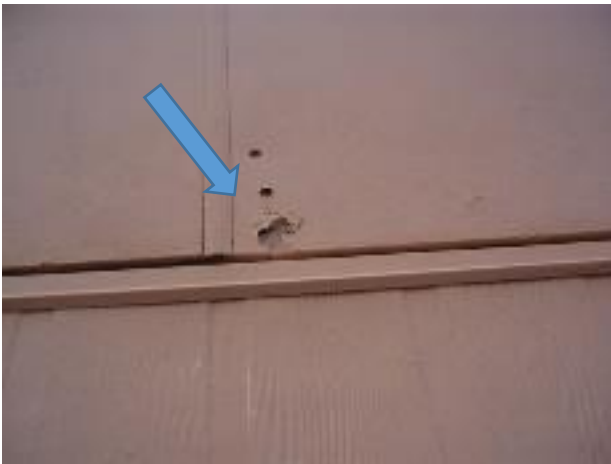
2. Again North elevation RHS of front door. The cladding here above the eaves line is of oil tempered hardboard sheets. This was commonly marketed as Weatherside or weathertex. It is considered a failed product & it can be seen that it is now in very poor condition due to moisture.

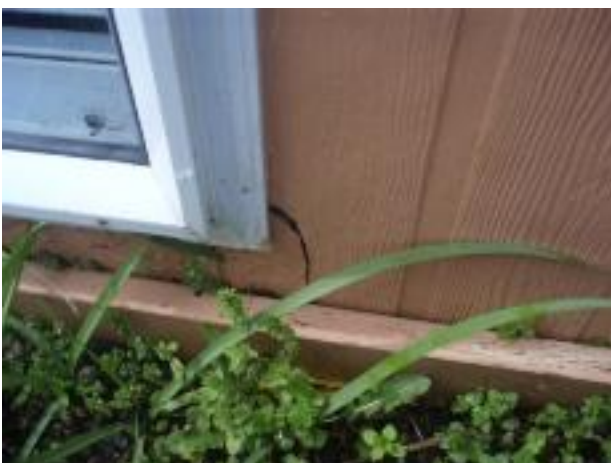
4. Again North elevation, this shows damage to the fibrolite cladding on the RHS of the lounge ranchslider. Clearly this is not weathertight.

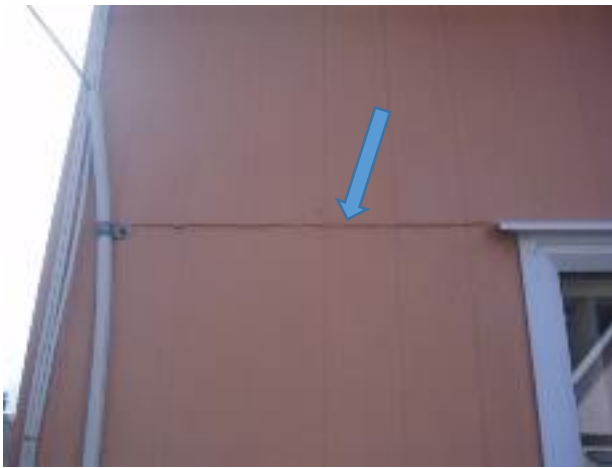
5. West elevation.  
The horizontal joint in the fibrolite cladding at the window head height lacks a flashing. It does not appear to be weathertight.

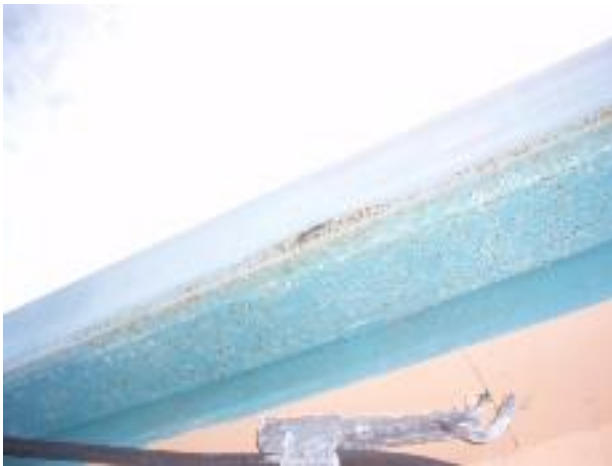
6. The metal spouting has perforated through due to corrosion.

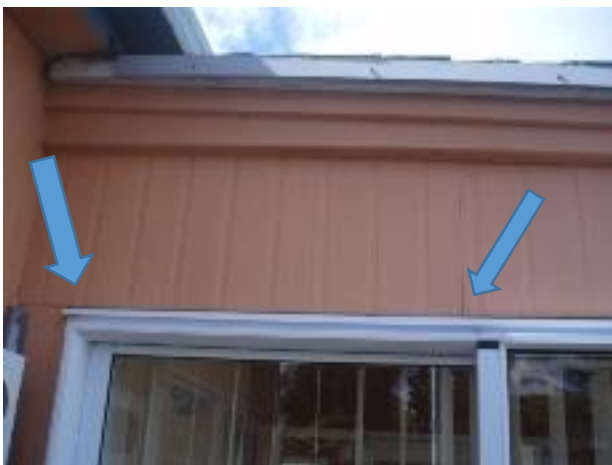
7. Again no Z flashing at the horizontal joint & in the cladding above the center of the window the cladding sheets have not been butted together tightly so the LH sheet is not tightly into the plastic jointer strip.

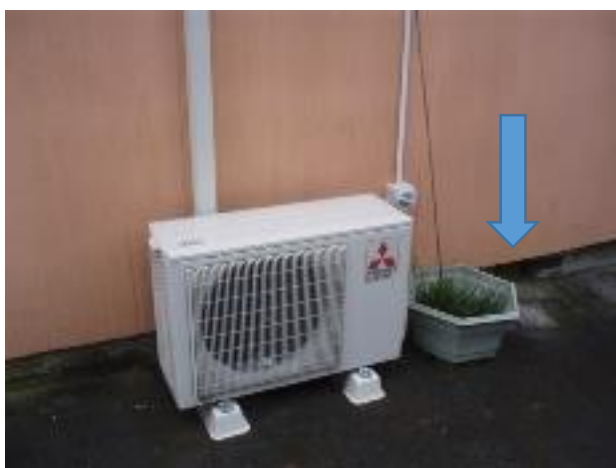
9. The bottom of the cladding to the RHS of the heat pump is loose or not fastened. It could be that the nail shanks have rusted through.

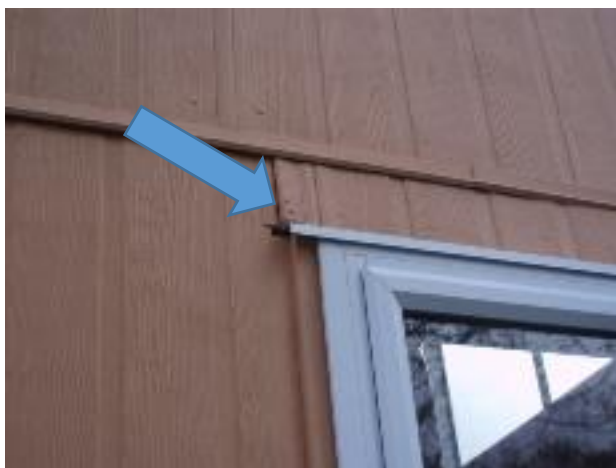
10. South Elevation.  
Both ends of the kitchen window head flashing are obviously not weathertight.

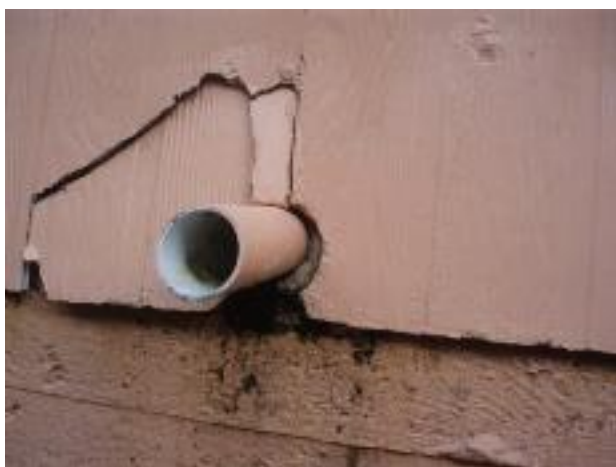
11. I noticed green algae & a lot of moisture under this overflow pipe under the kitchen window. Whilst investigating it I accidentally broke the already cracked fibrolite cladding. The fibrolite was in poor condition due to dampness. I removed the broken section & was able to see the timber bottomplate behind it...

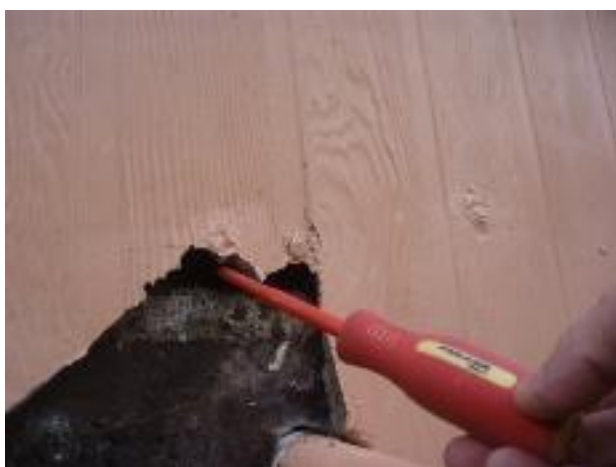
12. The bottom plate appeared to be soft & friable due to timber decay...

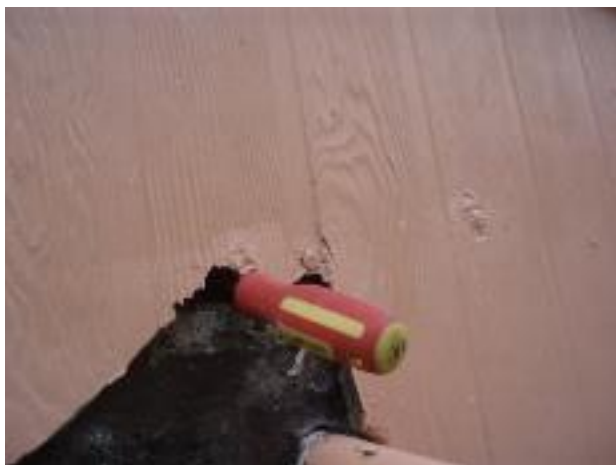
13. I was easily able to push my screwdriver through the decayed bottom plate.

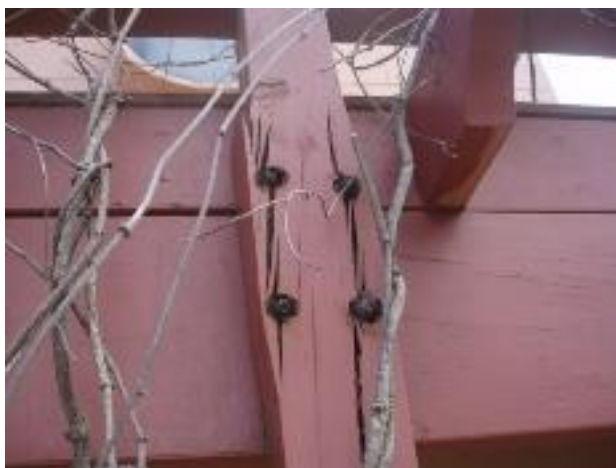
14. East elevation.  
The bolts that secure the first floor deck to the posts are generally very decayed. The posts are slender & in some cases require replacement.

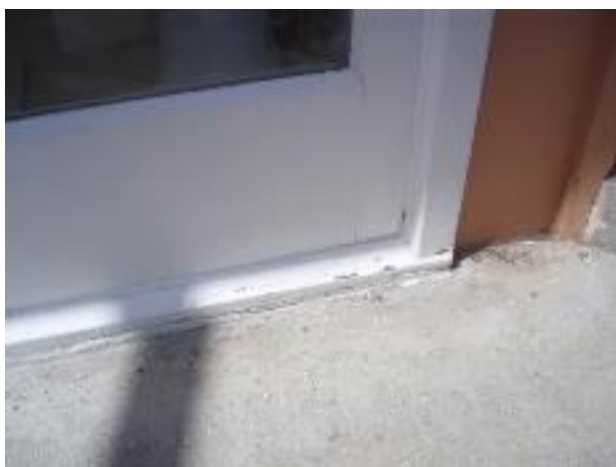
15. North elevation (to the left of the front door).  
The exterior pavement is almost at the same level as the bedroom floor. The sill of the French Door unit is decayed.

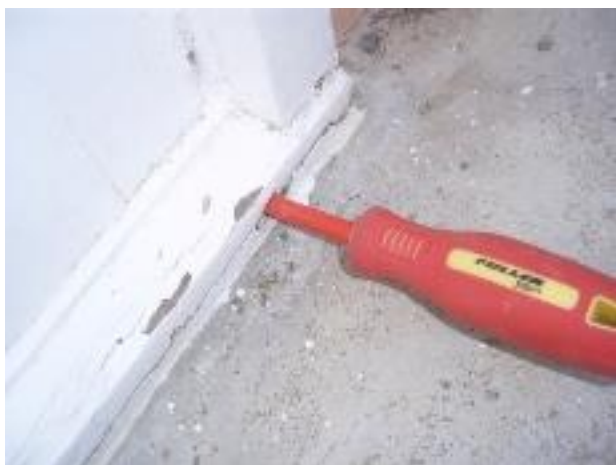
16. I was easily able to push my screwdriver into the decayed sill of the French door.

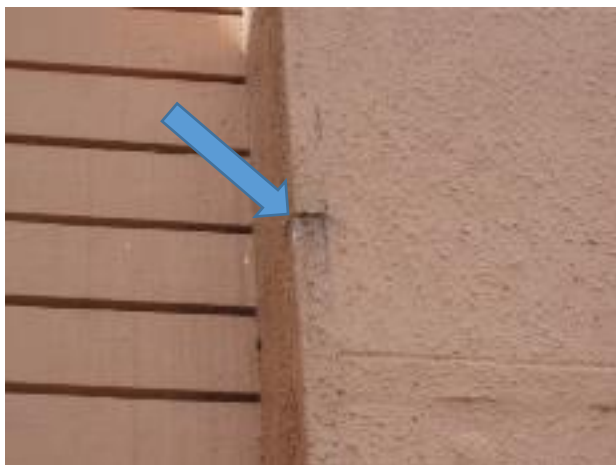
17. There are obvious signs of water ingress around the stair void.

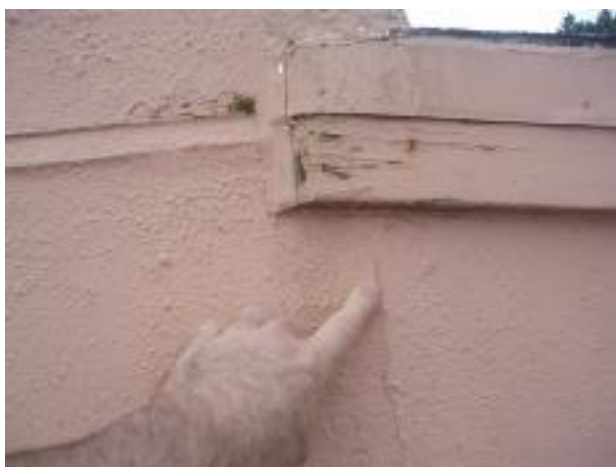
19. In this junction a butynol tiled roof meets the stairwell. It does not look weathertight & signs of moisture ingress are visible...

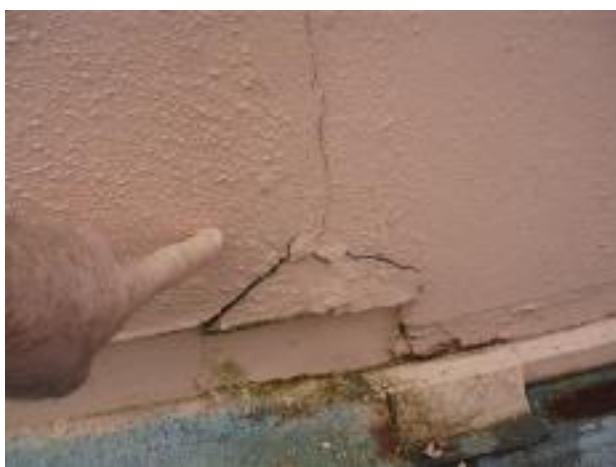
20.....I followed it down to where it meets the "brownbuilt" metal roofing above the hallway & you can see this broken piece of cladding. I was able to move the broken piece to one side & insert my screwdriver into the decayed timber framing.

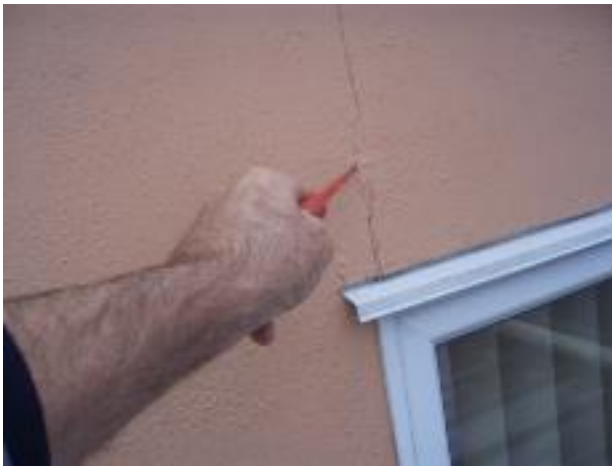
22. This shows a failure of the cladding above the high windows of the dining area.

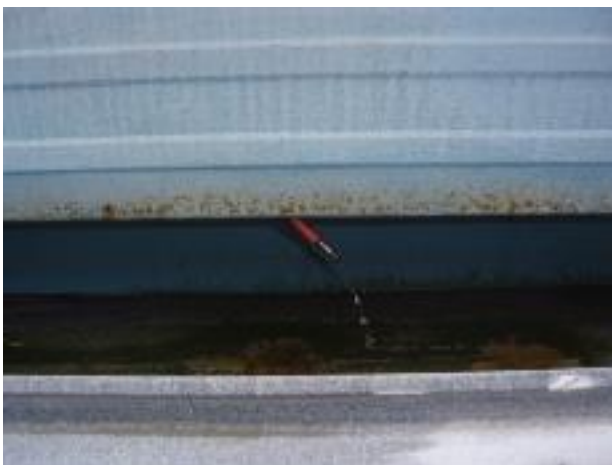
23. Here you can see the tip of my screwdriver which I pushed through the corroded bottom of the metal spouting above the hallway.

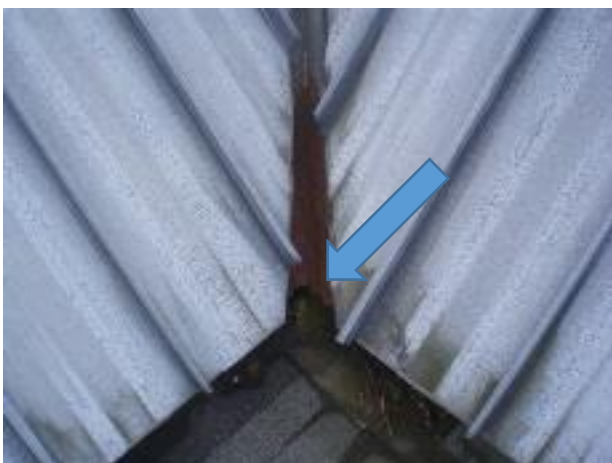
24. The bottom of the valley liner here is badly corroded.

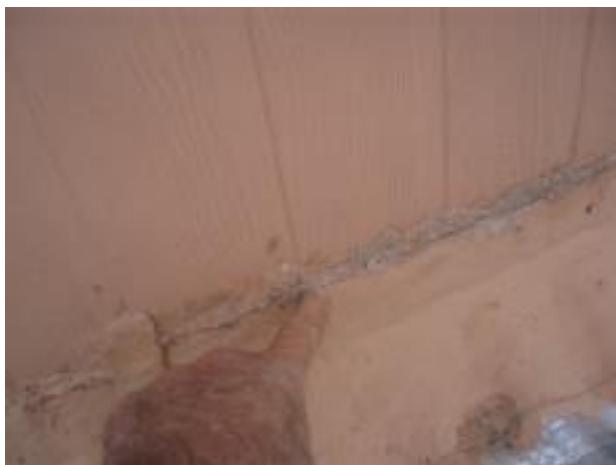
25. The apron flashing to the sunroom roof on the SE corner of the building does not lap under the cladding. It has been planted onto the front & siliconed.

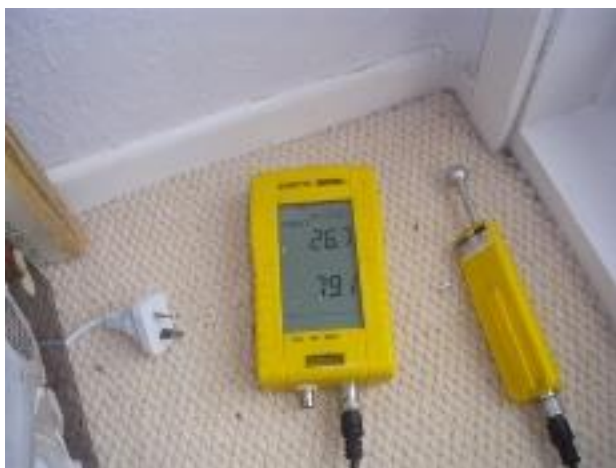
26. Inside / moisture readings.  
I received elevated moisture readings on the LHS of the French door unit in the downstairs bedroom (north wall).

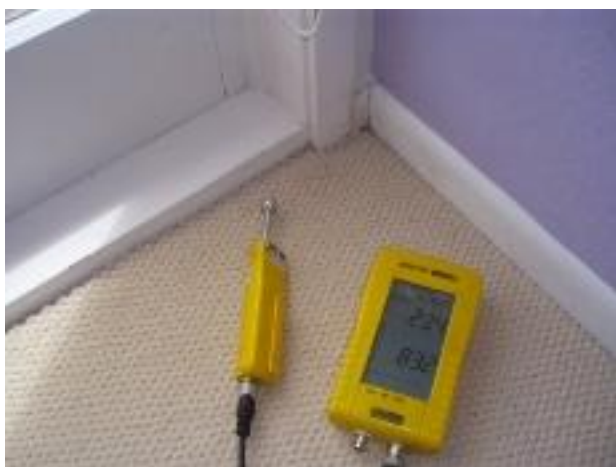
27. I also received elevated readings on the RHS of the same French door unit.

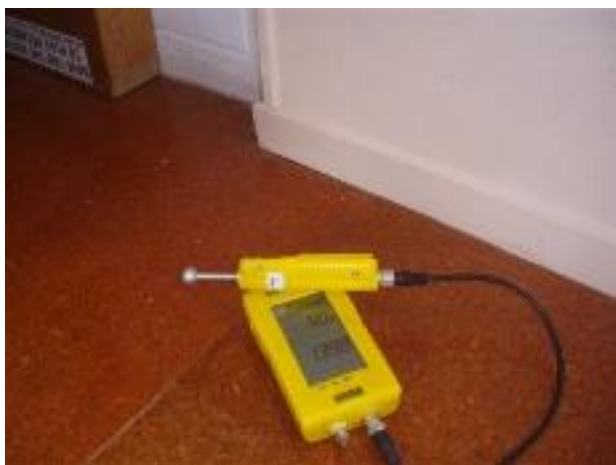
28. On the North wall at the bottom of the stair well I received very high moisture readings. I also noted in this area a patch repair to the wall paper.

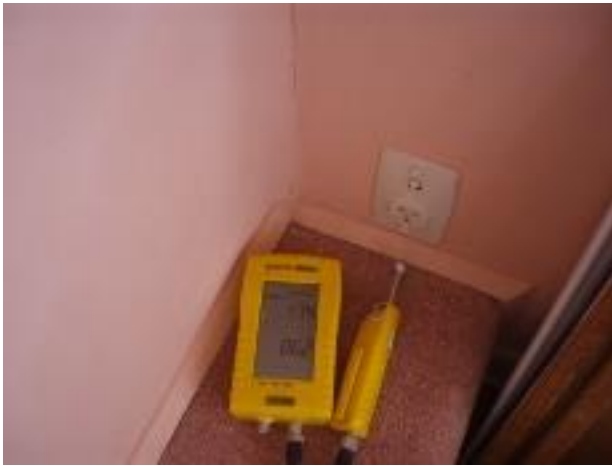
29. In the office on the first floor by the stairwell I received high moisture readings.

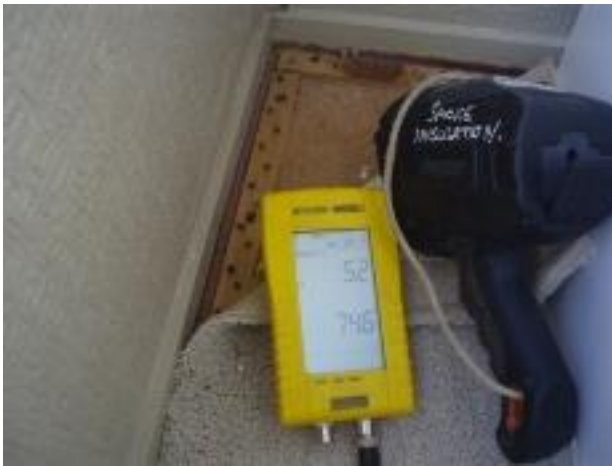
30. I received high moisture readings on the skirting boards & on the particle board flooring in the SW corner of the upstairs Master bedroom. Also note the discoloration & corrosion of the carpet tack strip.

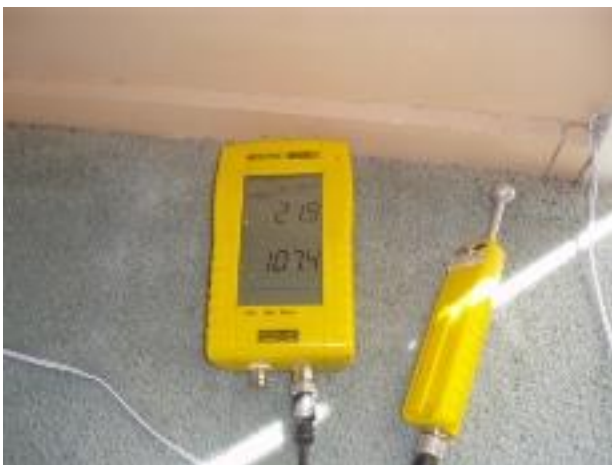
31. I received elevated moisture readings on the LHS of the ranchslider in the lounge.

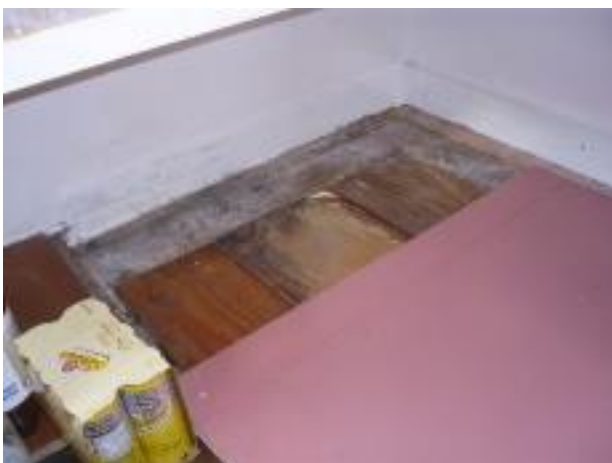
32. Access to the water tank is via this trap door in the pantry.

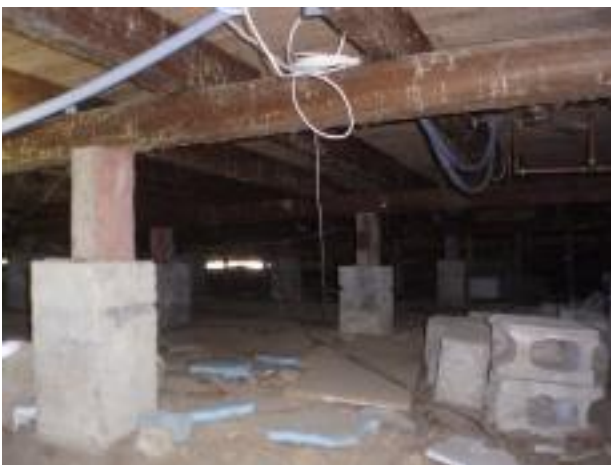
35. The subfloor structure looks to be in generally good condition given its age however sign of borer is present so it requires fumigating. The floor is not insulated. Also some areas have been excavated & the piles undermined. These areas need attention i.e. the undermined piles need to be re-stabilized.

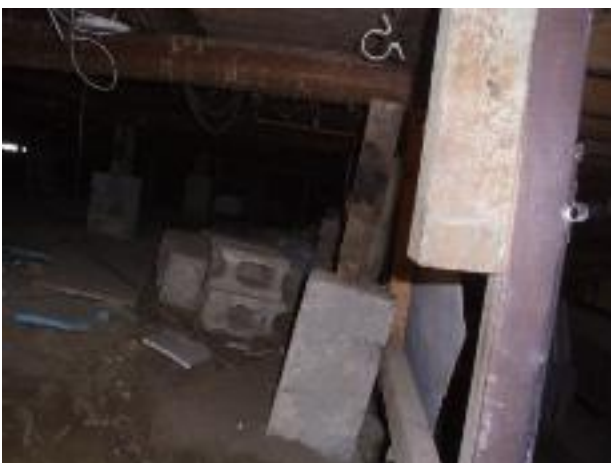
36. This shows a concrete pile that supports a timber jackstud. It has been undermined & has rotated to a significant degree. This should be considered unsafe.

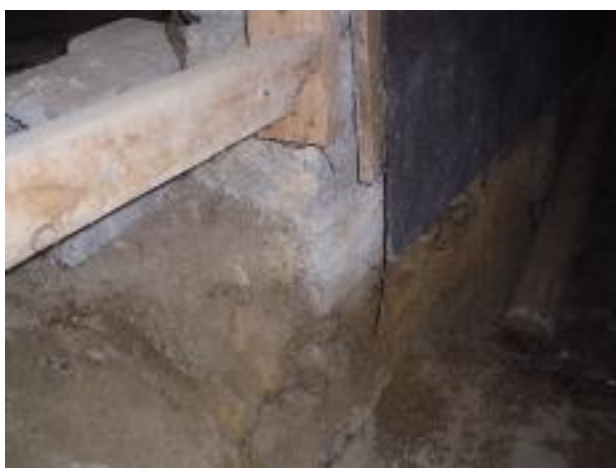
37. Another undermined pile.
