Property Inspection of xxxxxx

Date of Inspection: xxxxxxxx, 2017

The subject house is a new build. I was called upon by the client to comment on the build quality & workmanship.

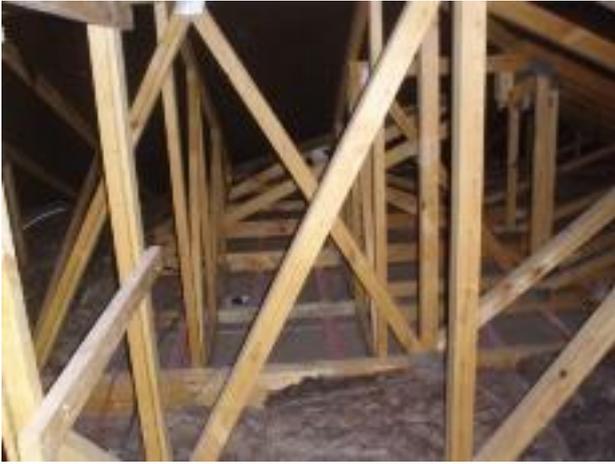
1. I inspected the roof from above & also from within the ceiling cavity. My impression is that it has been constructed to comply with the building code & to an acceptable standard. The ceiling to the house is insulated & there is no insulation to the ceiling above the garage space.

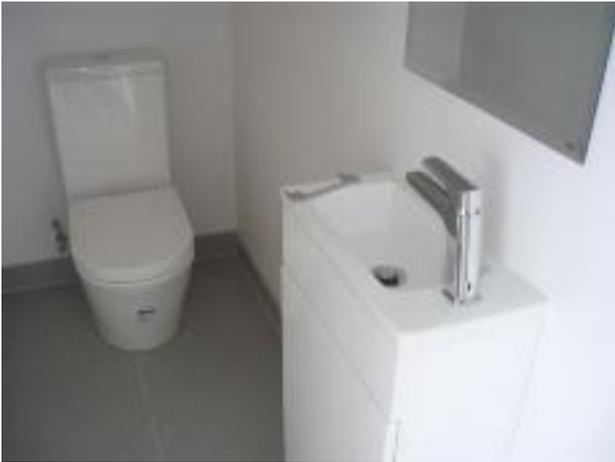
2. The vanity cabinets in all 3 bathrooms have not yet had the door handles installed.

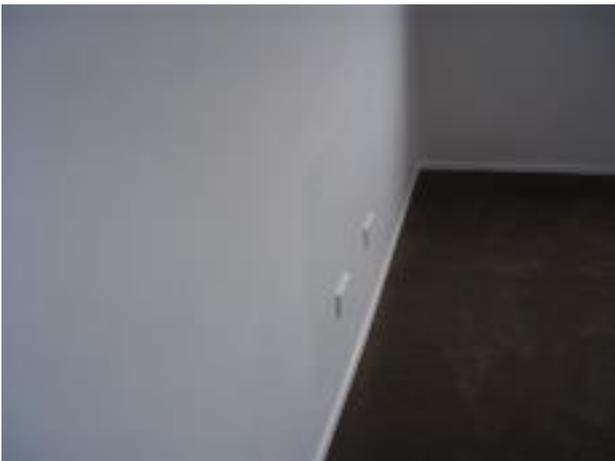
3. This wall in the master bedroom has a noticeable change of color tone in the middle of the wall. This should be remedied by re-painting the wall.

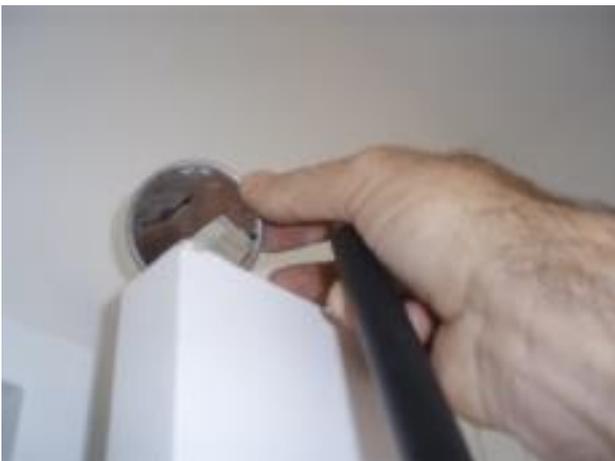
4. Also in the master bedroom there is minor damage to the top of the door. This should be touched up & the top edge of the door painted or sealed. The closet doors in the bedroom on the West wall require adjustment. It seemed to me that the magnetic door catches need to be rotated so the polarity is correct. Other than these minor items the interior is in satisfactory condition.

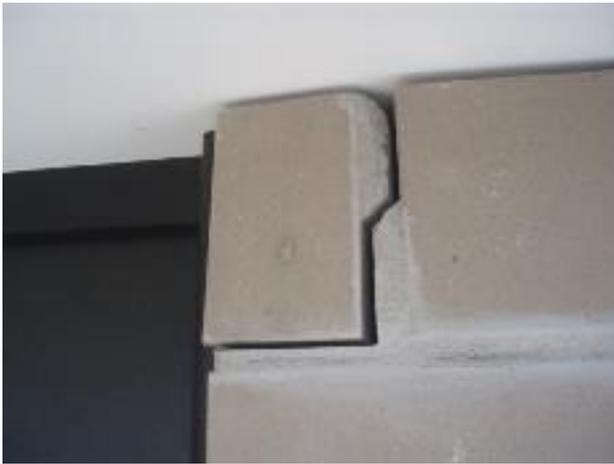
5. The exterior & brickwork.
 I am not impressed with the quality of the bricklaying & the finish of the brickwork. I found this loose brick on the RHS of the front door & another one on the bottom left side of the front door. The bricks are generally not laid in a uniform manner. There are large variances in the thickness of the mortar joints & the bricks deviate in plane to an excessive degree which overall gives an untidy appearance. Also the bricks have not been kept clean during laying & there is a lot of mortar splatter on the face of the brickwork.

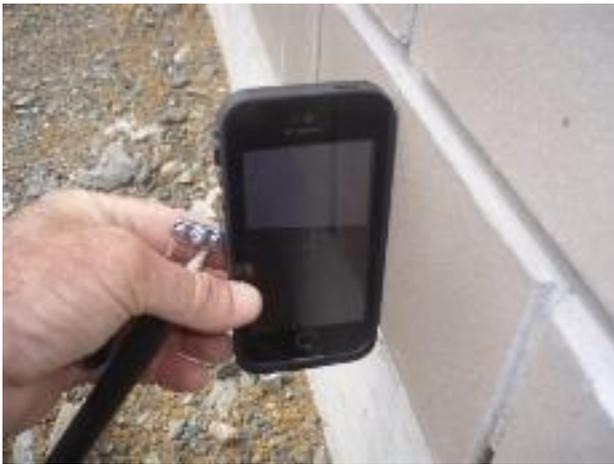
6. Here on the bottom course of brick work on the LHS of the front door the brick overlaps the edge of the floor slab an excessive amount & this has resulted in the bricks rotating before the mortar set as you can see illustrated by the level APP on my phone.

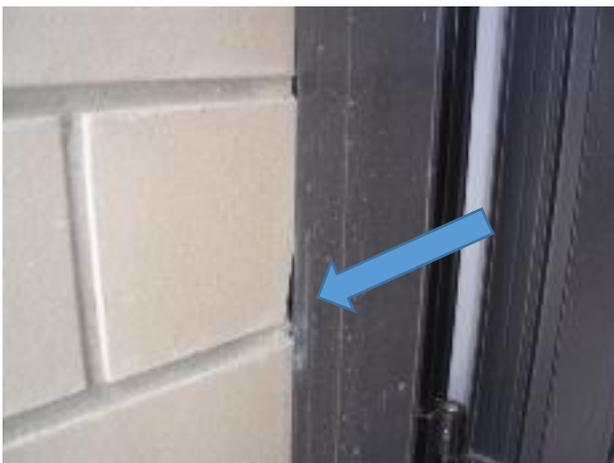
7. Again by the front door the frame of the door does not sufficiently cover the end of the brickwork. The code requirement in E2 asks for a minimum of 15 mm cover.
 To better illustrate this see copy of fig.15 below.

Overall I was not impressed with the quality of the brickwork or the finish to the exterior pavements. I am particularly concerned with the lack of cover as discussed in item 7 & the non stopended headflashings. Because of these 2 faults it is my opinion that the work falls short of complying with clause E2 of the NZ Building Code.

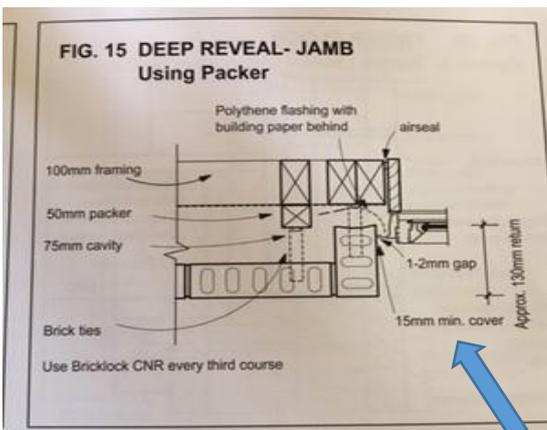
8. This detail shows a plan view of a normal deep reveal door or window jamb. Note the 15 mm minimum cover requirement at the edge of the aluminium fin of the window.

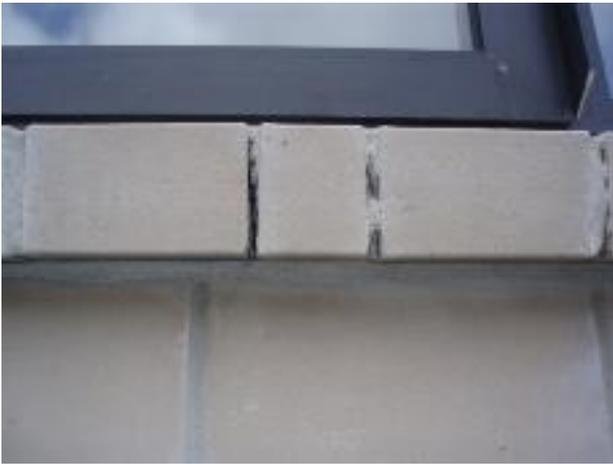
9. This shows an example of very poor mortar jointing on a windowsill on the South wall.

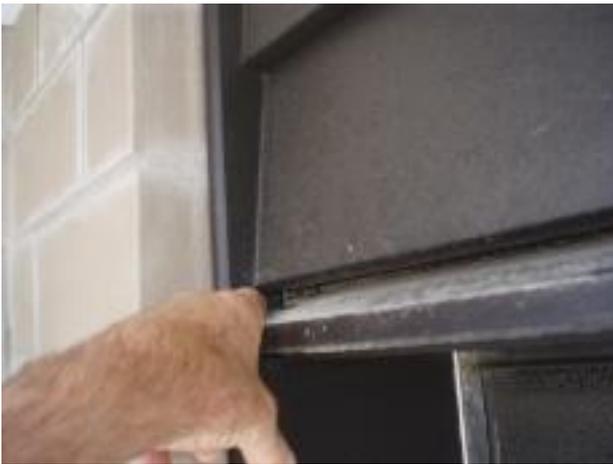
10. The headflashings have not been stopended so therefore they are not weathertight. There is nothing to stop rainwater getting past the end of the headflashing & into the wall cavity. This is a serious defect that must be rectified before you make a commitment to purchase this property. Failure to rectify could lead to premature decay of the windowsill & the timber framing adjacent the windows. It could also create a damp & moldy environment. My opinion is that this defect renders the building non-compliant with clause E2 of the NZ Building Code. This defect is typical to all of the windows.

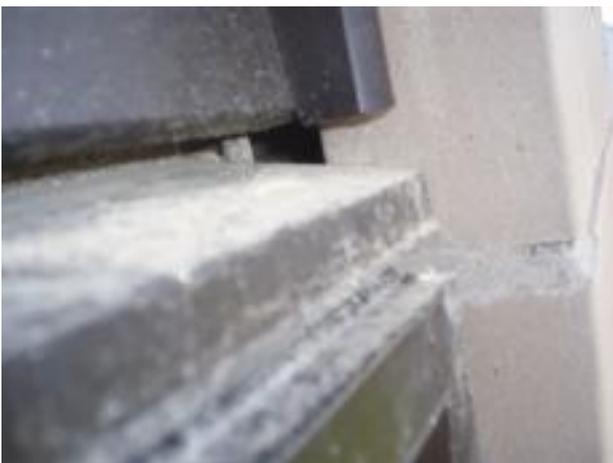
11. In this photo you can clearly see the non stopended headflashing & the gap where water can enter into the building cavity.

Comment: the weatherboard cladding above the windows is of finger jointed radiata, probably treated to the level of H3.1. Because they are painted black these weatherboards will absorb a lot of heat therefore they will be subject to a lot of thermal movement. It is my opinion that black is a poor choice of color for timber weatherboards.

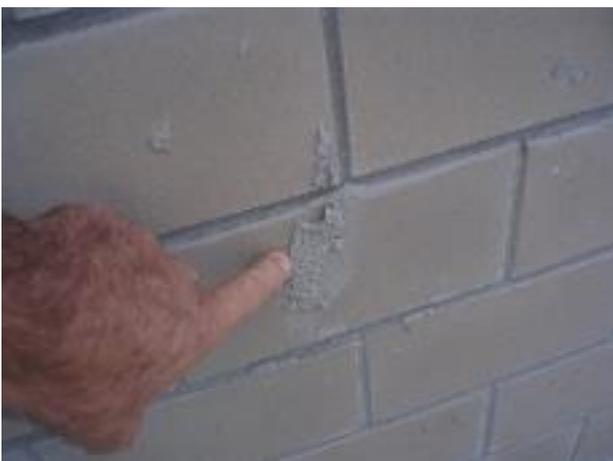
12. This shows mortar or concrete splatter that has been carelessly left on the finished brickwork. This will be more difficult to clean off now than if it had been cleaned off when it was wet. There are many such examples throughout the property.

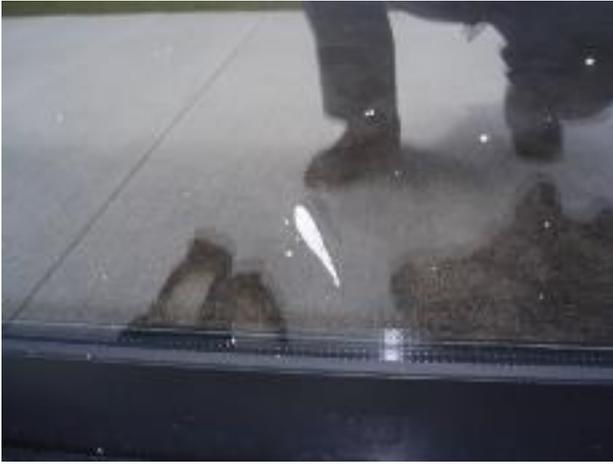
13. This shows concrete splatter on a window & on the aluminium joinery unit. Again there are many examples of mortar & concrete splatter on the joinery units.

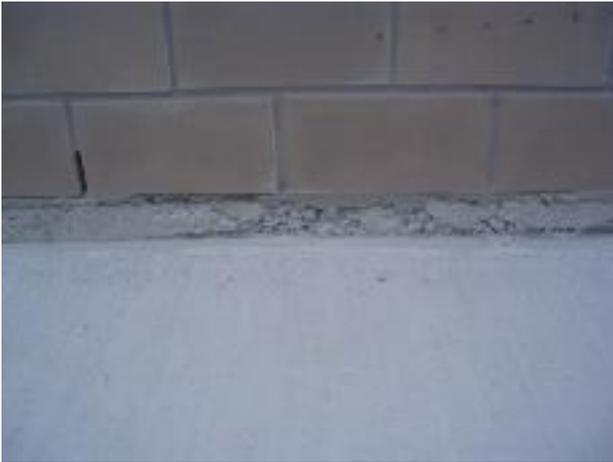
14. The concrete exterior pavement is a very untidy & unprofessional job.

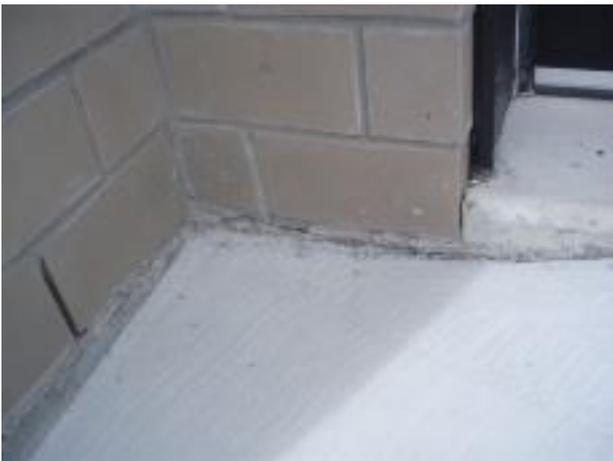
15. Another example of the very poor finish quality of the exterior pavement.

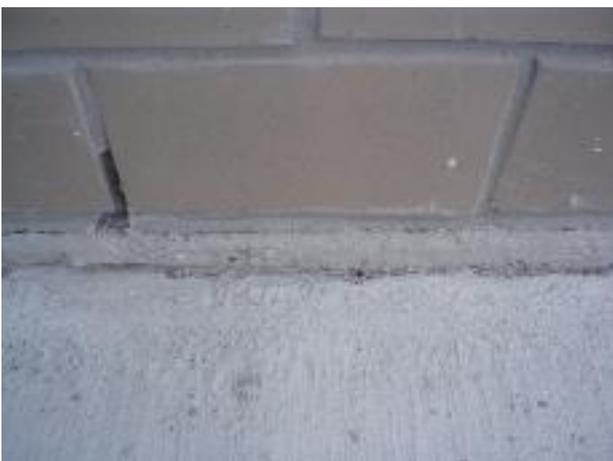
16. And another.

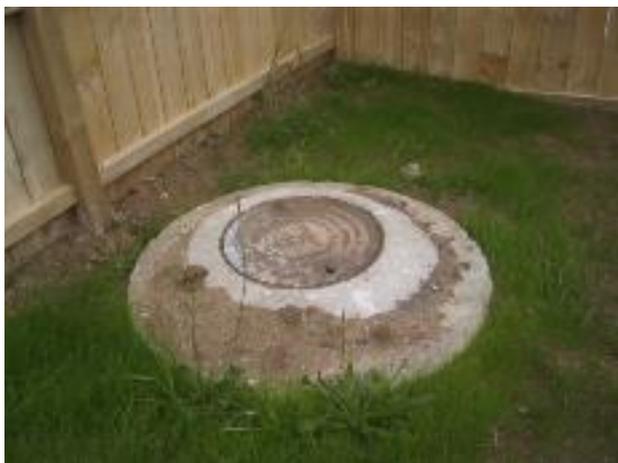
17. It would be a good idea to lower the concrete top of this manhole & support the cover with a riser so that this unattractive piece of infrastructure is less visible with only the steel lid showing at ground level.
