**Property Inspection of xxxxxxxxxxxxxxxxxxxx**

Prepared for: Angela & Brian xxxxxxxxx

Date of Inspection: 16<sup>th</sup> Feb, 2015

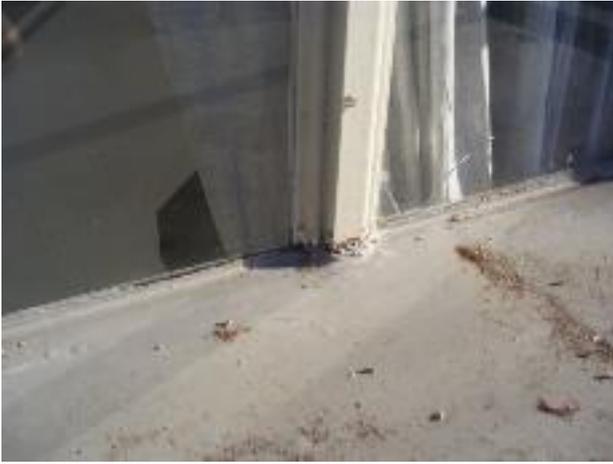
1. Here above the back door the butynol roof finishes against glass. This is a junction that is difficult to finish properly & must require constant maintenance.

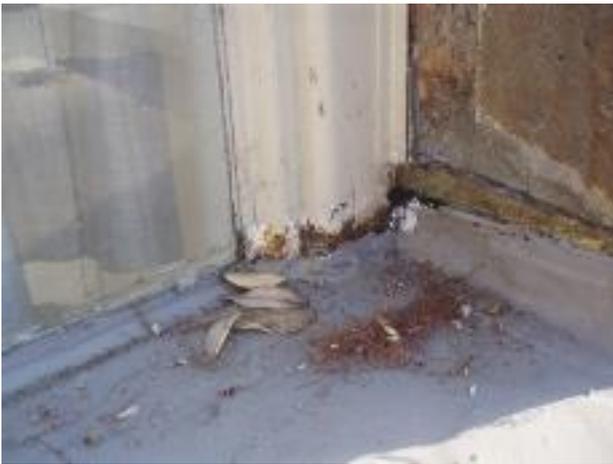
2. This is a close up of the above mentioned area & it appears rainwater runs down the SHS at the roof / portal to cladding junction.

48. Water damage is visible on the gibboard wall in the entry lobby. The water ingress here may well stem from the steel portal highlighted in photo 2 & 3.

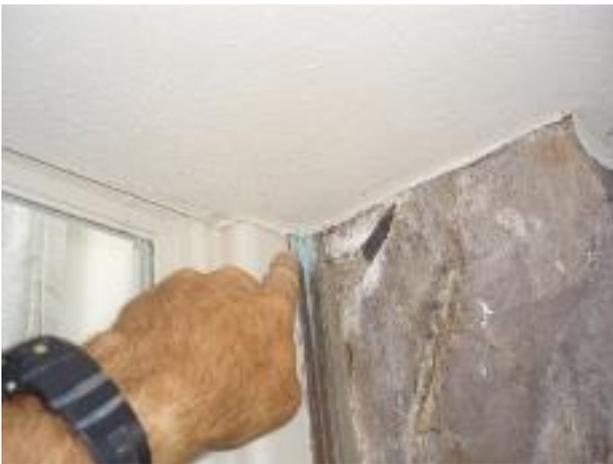
3. This is below the above mentioned junction. You can see water staining on the copper flashing.

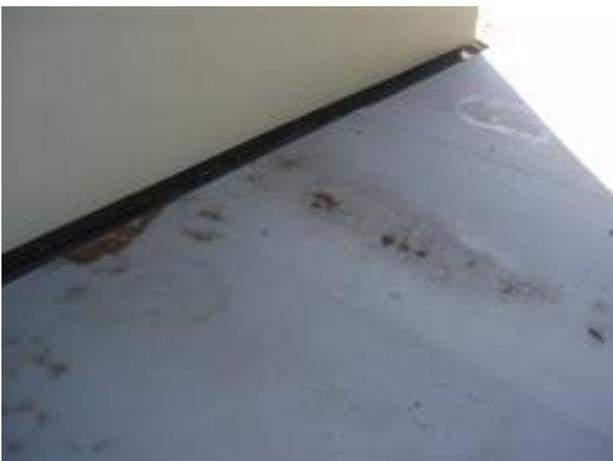
4. On the Western side of the lower flat roof there is an area where the substrate moved from the weight of me walking on it. This may be due to decay of the substrate.

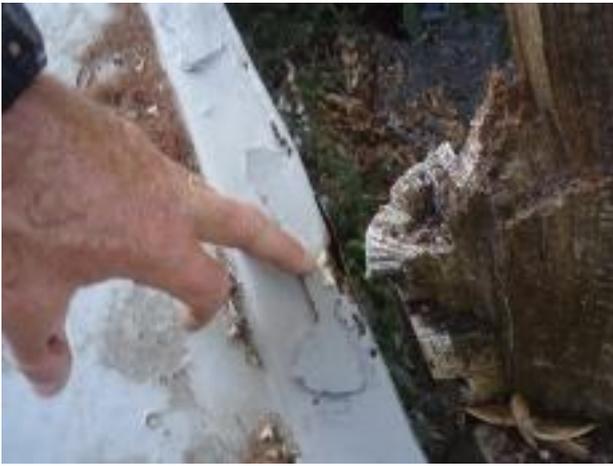
5. Here you can see a metal cap flashing on the Western edge of the lower butynol roof. It has rusted away & the paint on membrane has been applied over the remnants of it.

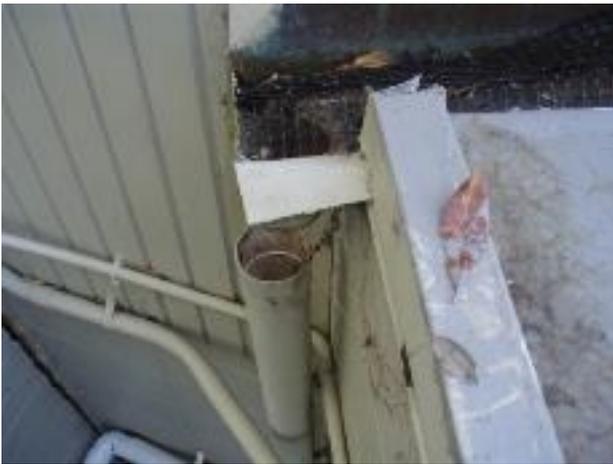
6. The down pipe to the lower roof is dislodged.

Comment: the spouting & the Western part of the roof has a lot of leaf litter & debris on it. It should be cleared regularly.

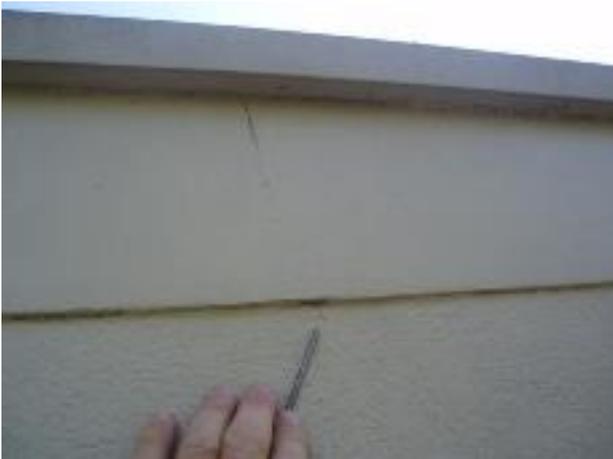
7. In places hairline cracks are visible in the EIFS cladding, particularly at this junction where the EIFS abuts the fascia board.

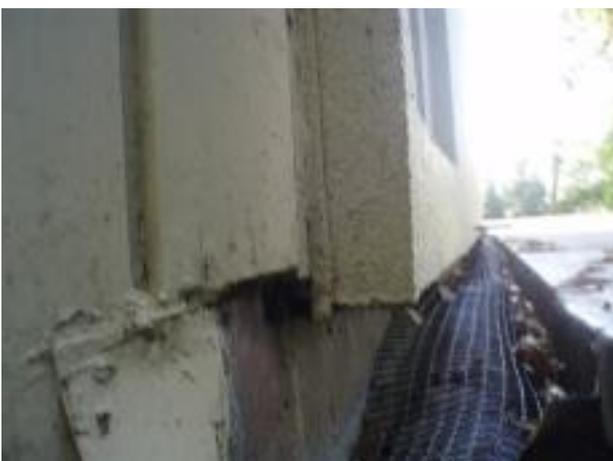
8. Here is a junction where you can see the original cedar cladding & the new EIFS. It appears that the EIFS has been clad directly over the cedar.

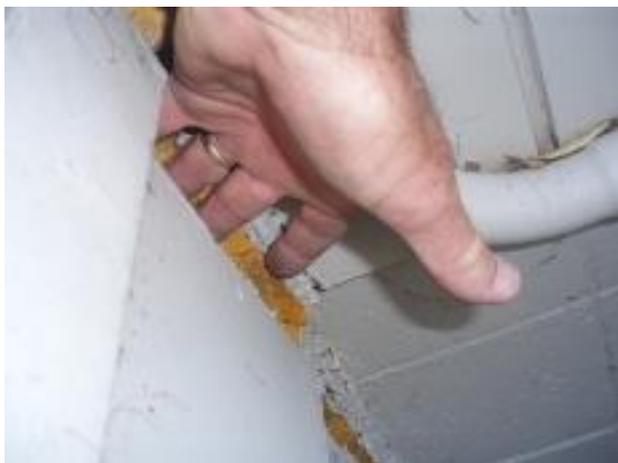
9. The concrete floor of the cupboard off the garage has settled causing this gap to open up.

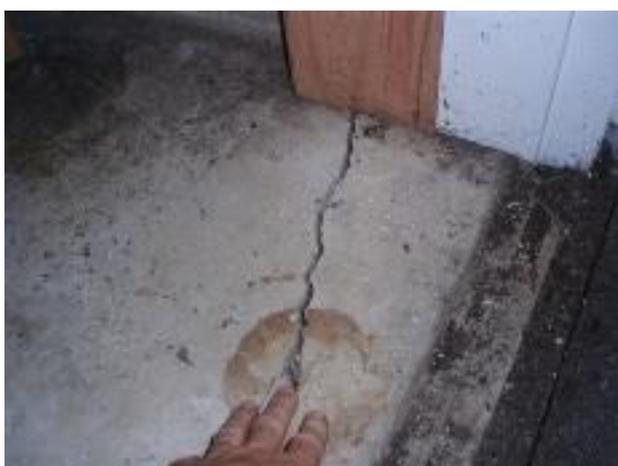
10. This shows the crack in the concrete floor. The floor has slumped noticeably.

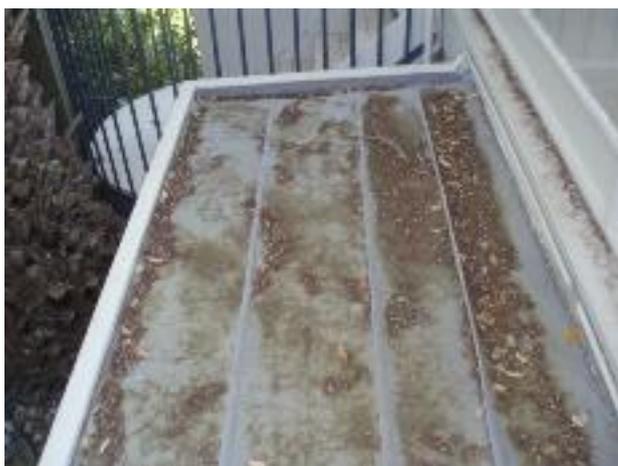
11. There is a lot of debris on the covered roof. It appears to leak & the gutter dropper (downpipe) is very small.

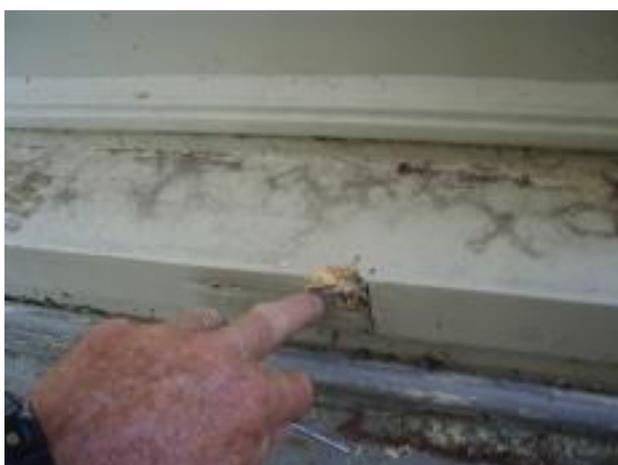
12. A decayed window sill on the Western wall of the lounge.

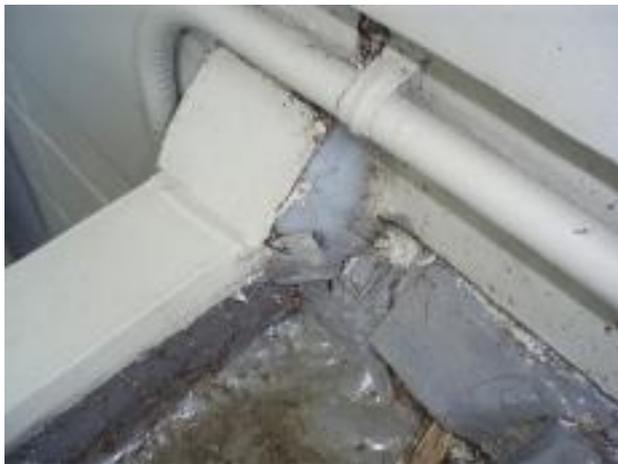
13. This junction of the cupboard roof to the cladding is not weathertight.

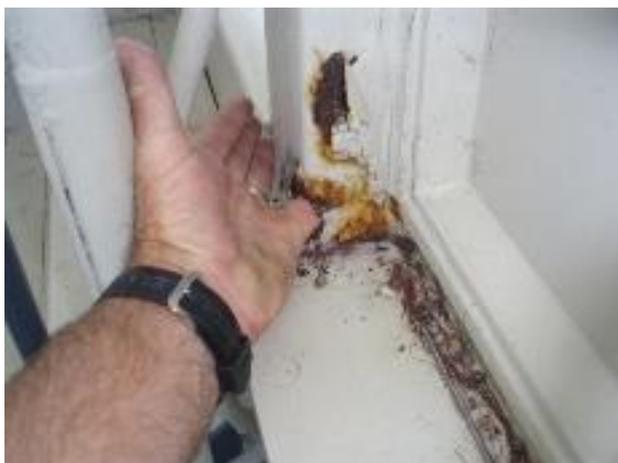
14. This shows severe corrosion of the SHS portal on the NW corner. You can see I have pushed my finger through the rust.

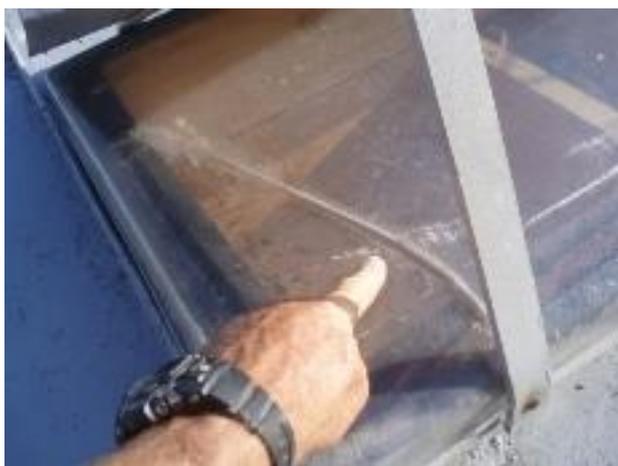
15. A broken skylight. This should be replaced ASAP.

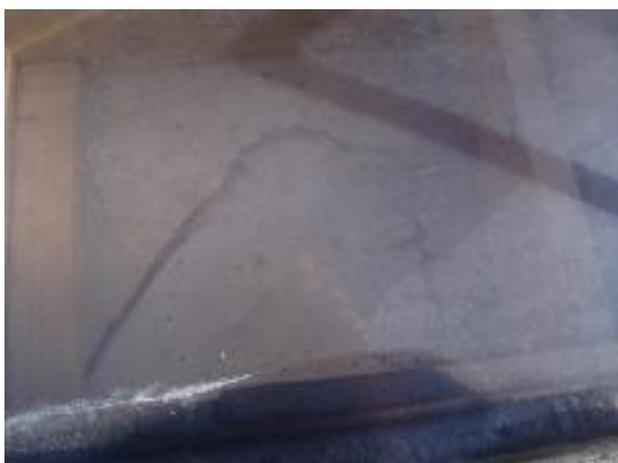
16. Waterstaining is visible on the gib board ceiling of the ensuite bathroom under the skylight. The leak is probably coming from the disused flue.

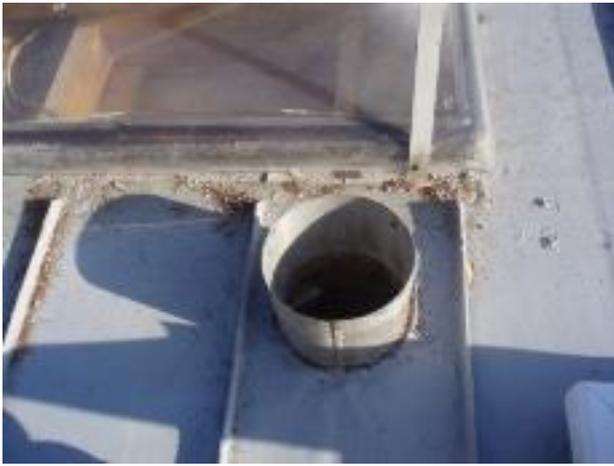
17. The disused flue.

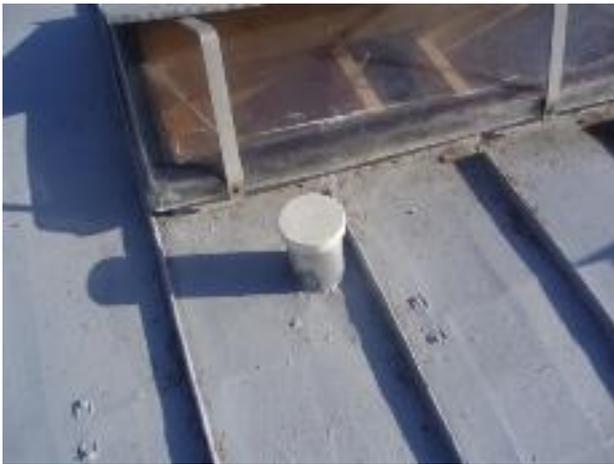
18. The roof has a lot of penetrations that appear to be superfluous.

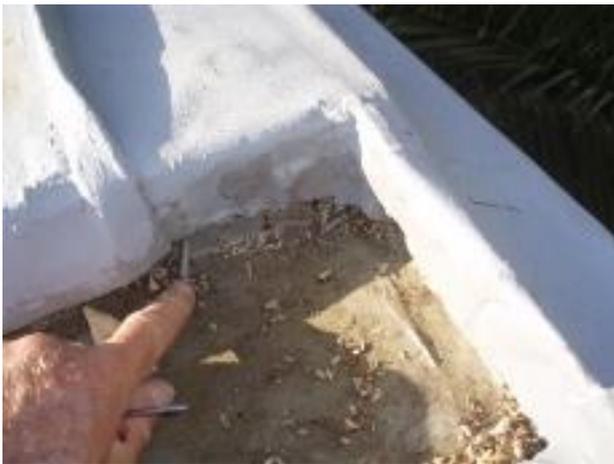
19. The entire roof has been covered with a paint on membrane but not a lot of attention was paid to detail & prep work. As an example I am pointing to a screw that was lying loose in the guttering & simply painted over.

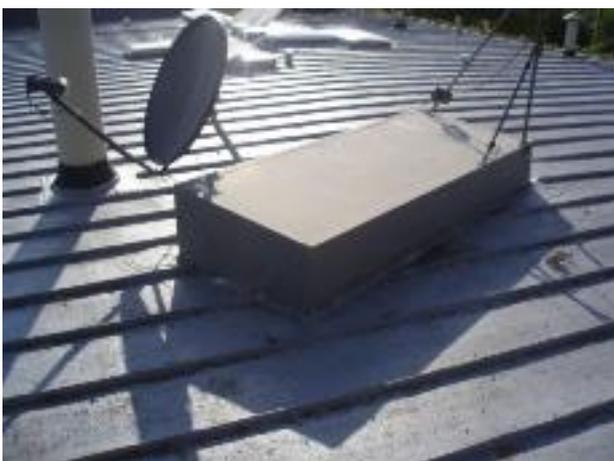
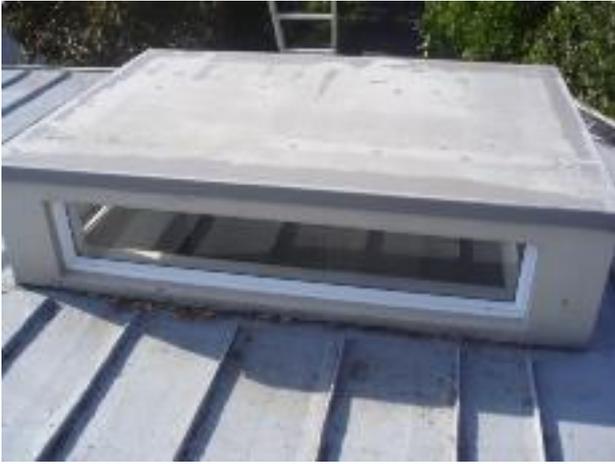
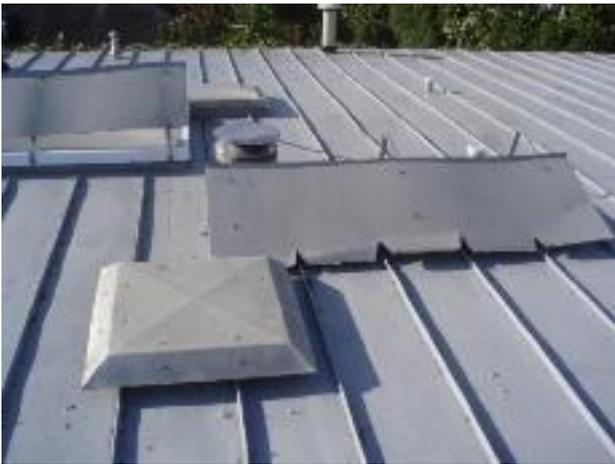
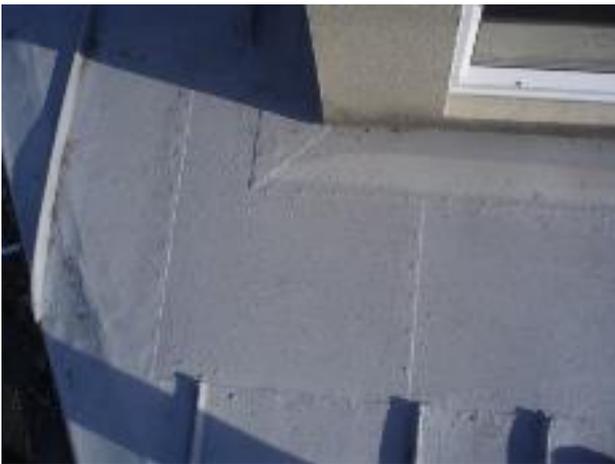
20. The roof has lots of penetrations & junctions. This is always a maintenance hassle on an old flat roof.

21. as above.

22. as above.

23. as above.

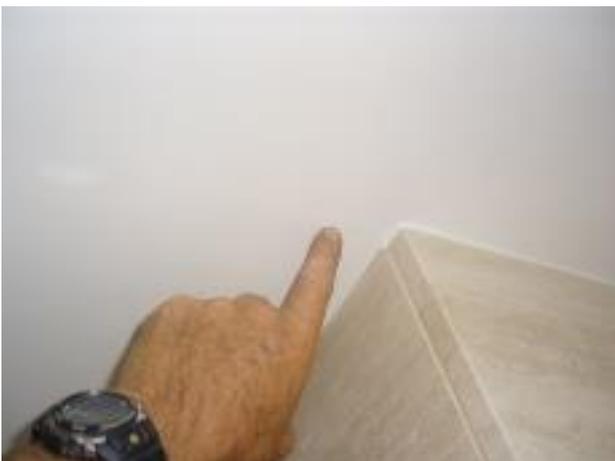
24. It is difficult to see in the photo but there is some damage to the gibboard ceiling below the skylight. See photo no. 16.

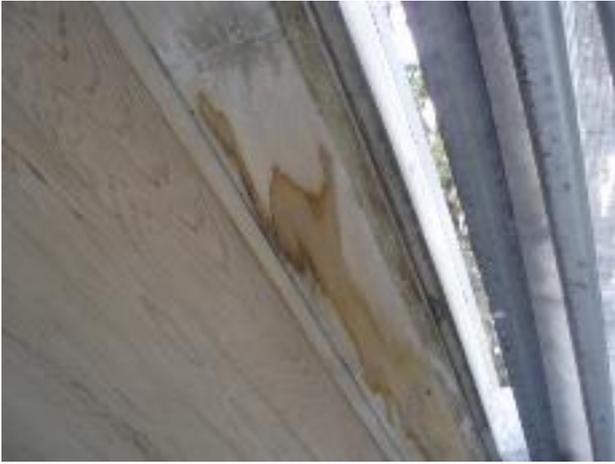
25. This waterstaining to the cedar soffit under the hidden gutter on the North wall is evidence of leaking.

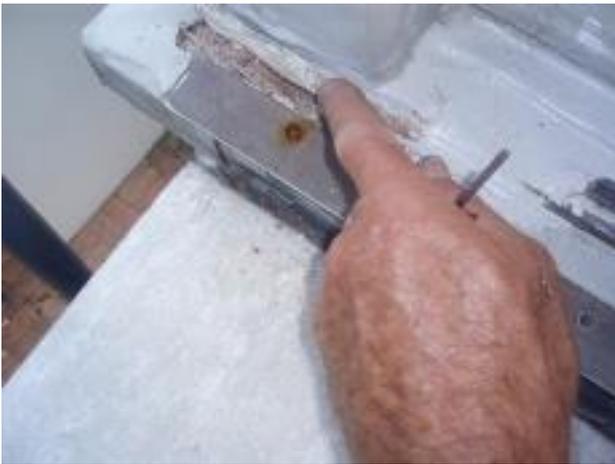
26. Water damage & corrosion is visible all along the base of the North wall.

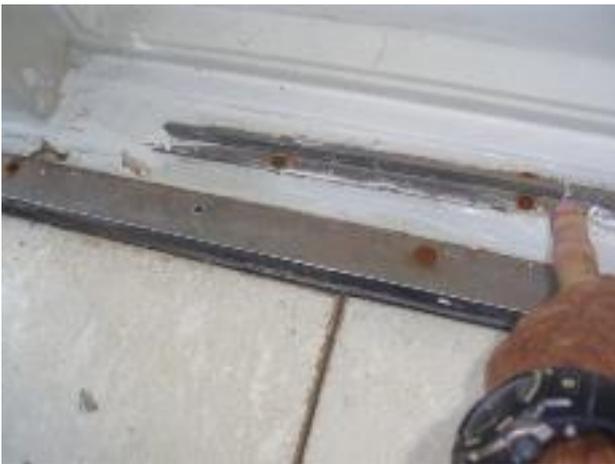
27. I took this photo to show that this area of the door track looked to be in poor condition....

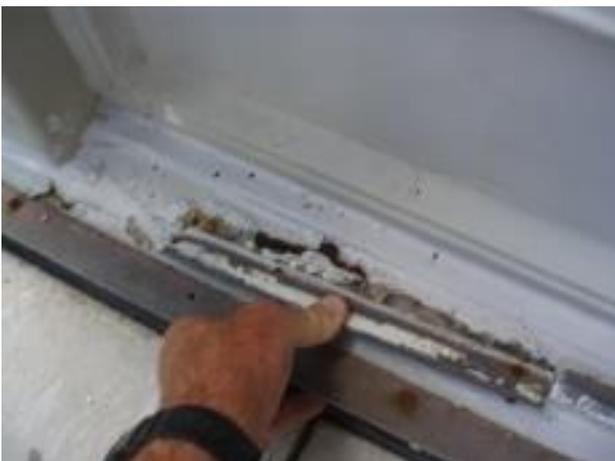
28...and a little later during the inspection I stood on it & it broke away.

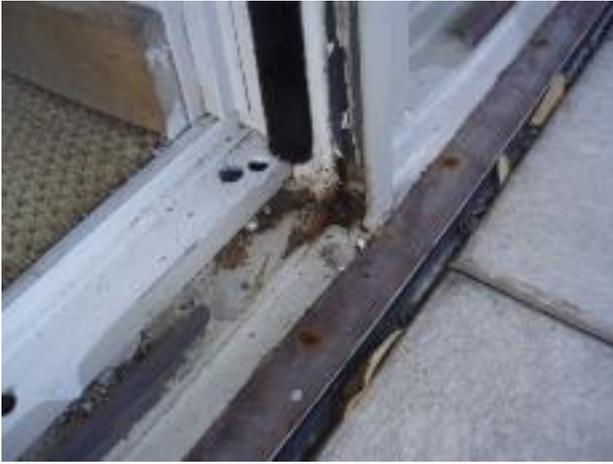
29. Another view of the door track of the North wall. Note the corrosion.

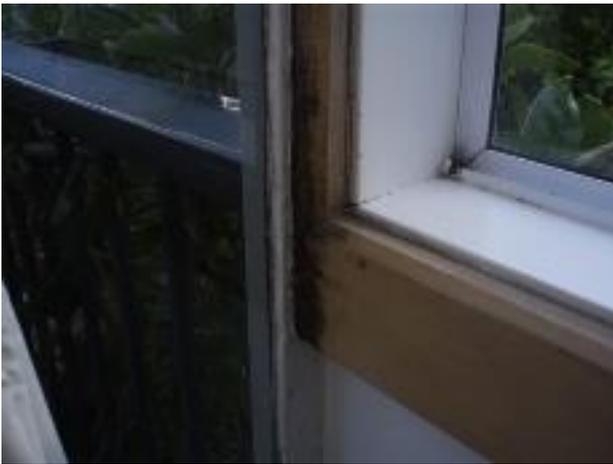
30. In the NE corner of the master bedroom the architrave of the window is discolored & moldy probably due to condensation around the steel window frame on the North wall.

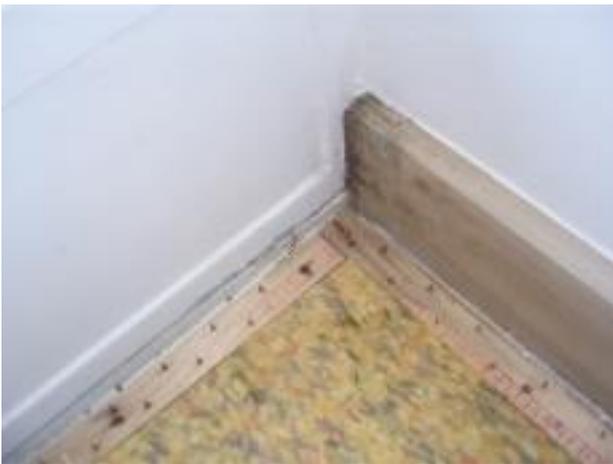
31. The same thing is visible on the skirting board directly below it. Again probably due to the condensation on the joinery unit. I received slightly elevated moisture readings in this location.

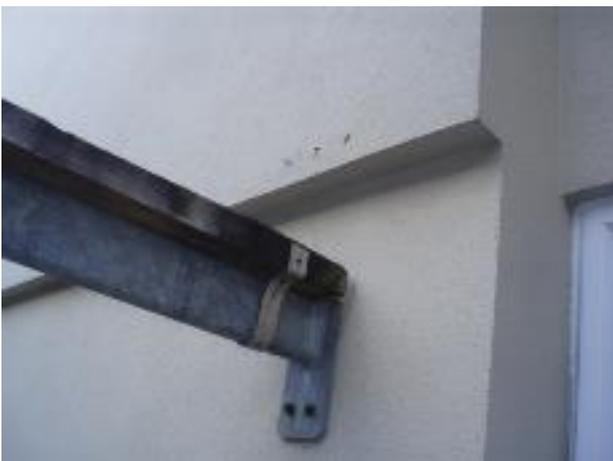
32. Water ingress likely occurs where this gate structure is bolted to the EIFS cladding. Also note the holes drilled in the cladding above the gate structure. They are not stopped up.

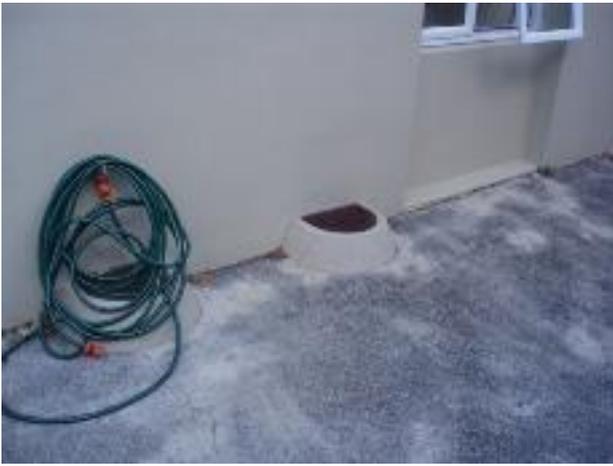
33. There are 2 gully traps on the Eastern wall. The overflow level of these appears to be higher than the lowest sanitary fixture – the downstairs shower. I recommend that the overflow level of these gullies be dropped.

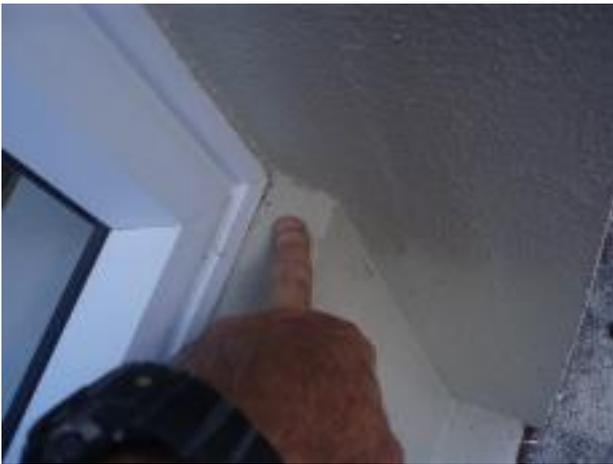
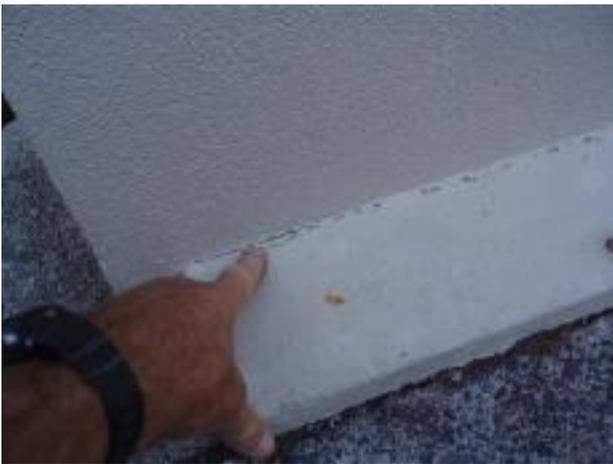
34. Small cracks are visible in the EIFS cladding on the Eastern wall.

35. as above.

Note: this appears to be at floor level. It looks as if the original blocks have been removed & because the EIFS is thinner than the original blocks the slab protrudes out past the face of the wall.

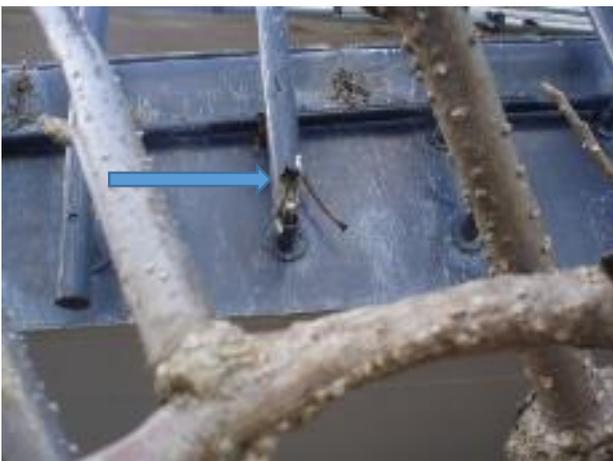
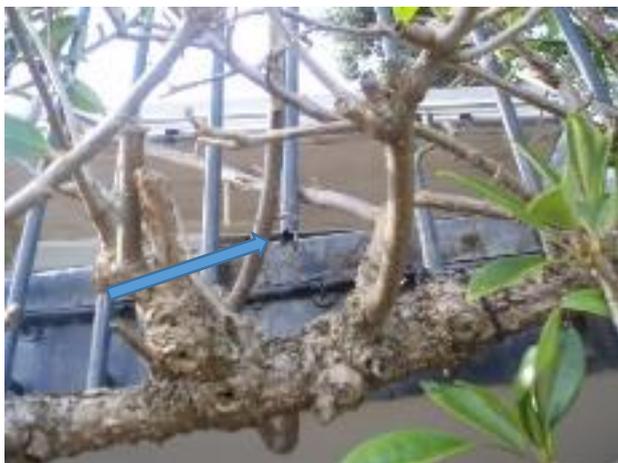
36. The handrail balusters are in poor condition. Several are broken away at the base.

37. as above.

Note: some of the balusters are steel tubing. Others are timber dowel. These loose balusters are a hazard to small children.

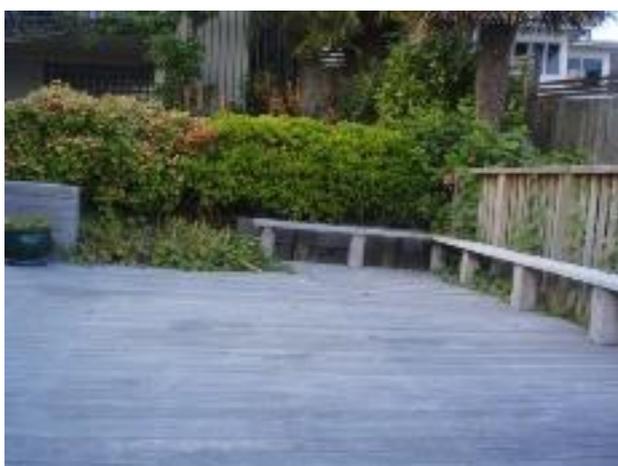
38. The timber deck at the rear of the property slopes noticeably down to the West. Presumably it was built level & ground movement is the reason.

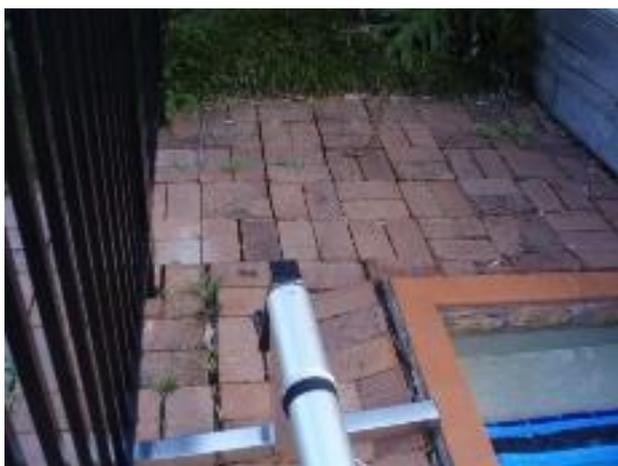
39. More evidence of ground movement in the landscaping around the pool. This is possibly due to loose fill not being properly compacted after the pool excavation.

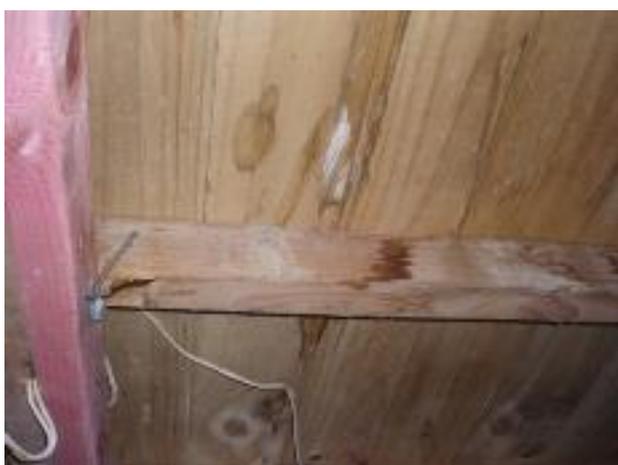
40. This is the ceiling of the cupboard off the garage. You can see that it leaks.

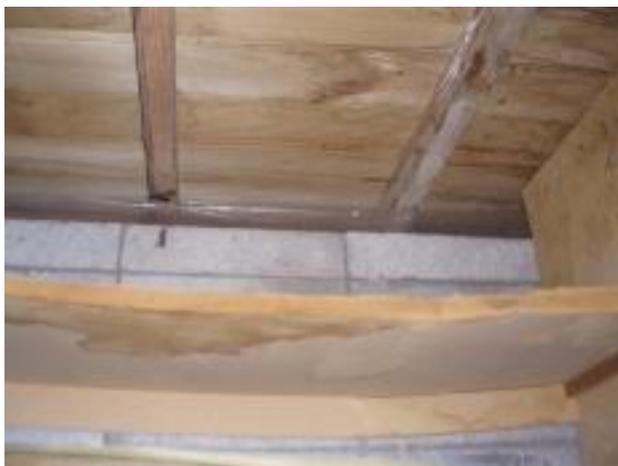
41. Another view of the cupboard ceiling.

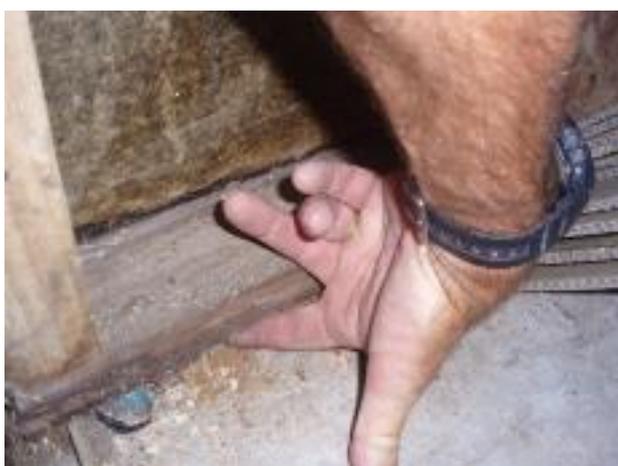
42. The bottom plate of the cupboard is severely decayed.

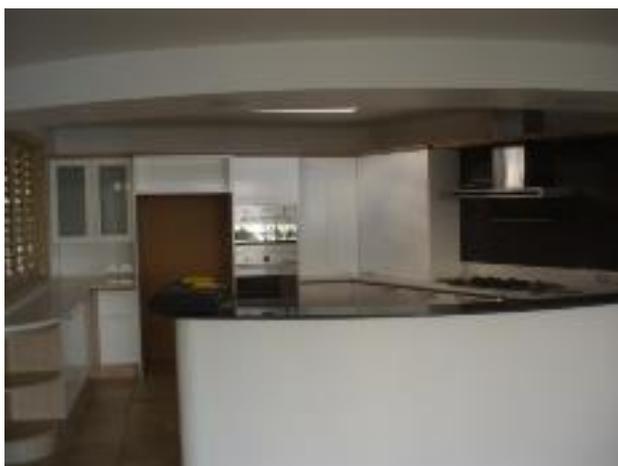
43. The kitchen looks to be of good quality & well installed. The cabinet fronts would have originally had a timber finish but they have now been painted over. I'll comment further in my summary.

The kitchen appears to be in good condition & a quality installation. In the pdf file of the plans there is correspondence between Jocelyn Cheung of Auckland City Council & Colin Pauling Assoc. (the Architects). In this correspondence Pauline points out that the area is zoned residential 2b & no changes are permitted to the exterior of the building without a resource consent. As a result of this the architect confirms he will delete the external changes. But it looks like they carried them out anyway & installed the EIFS & aluminium windows. This may be why they omitted to apply for a CCC.

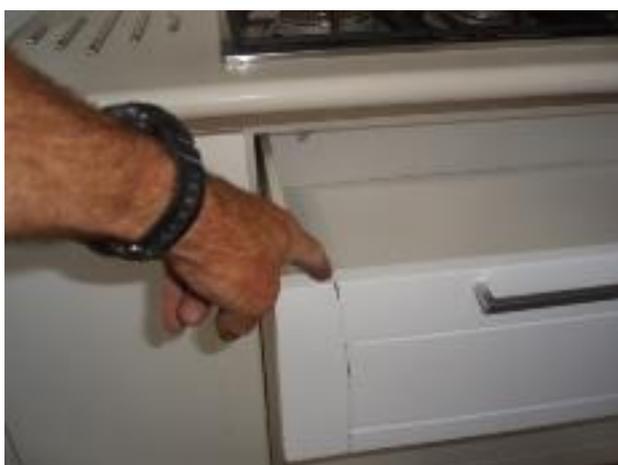
44. The drawer front has had a knock & the damaged portion glued back on.

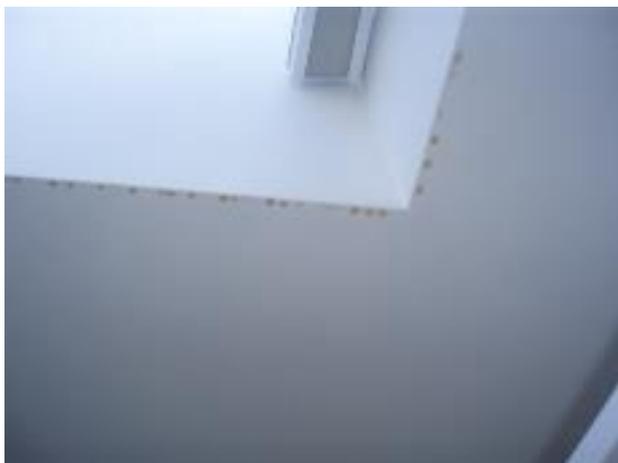
45. The discoloration around the edge of the skylight is caused by condensation / leaking.

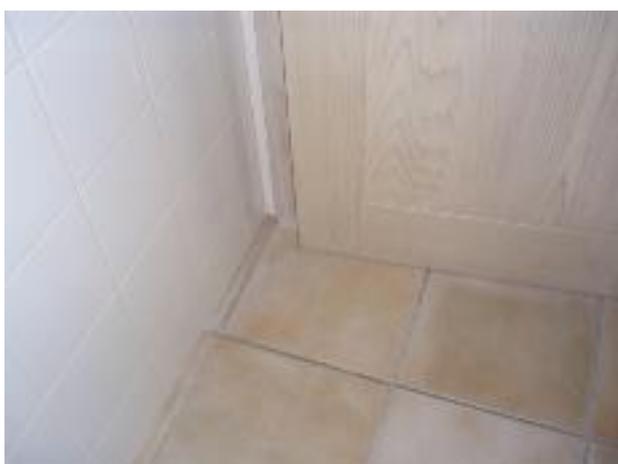
46. The toilet door binds on the floor, I think due to substrate movement.

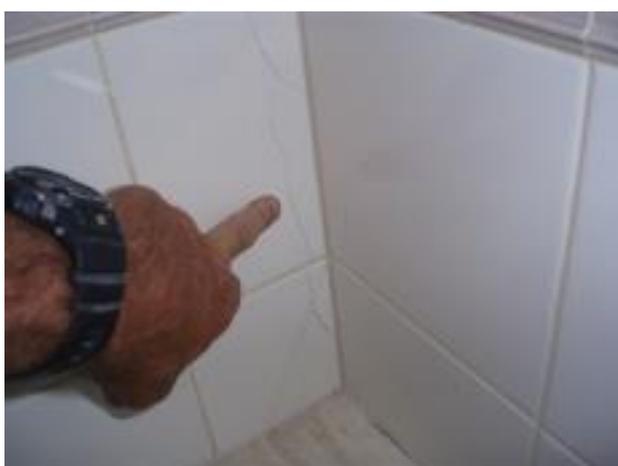
47. These cracked tiles, also in the bathroom, are probably also due to substrate movement.

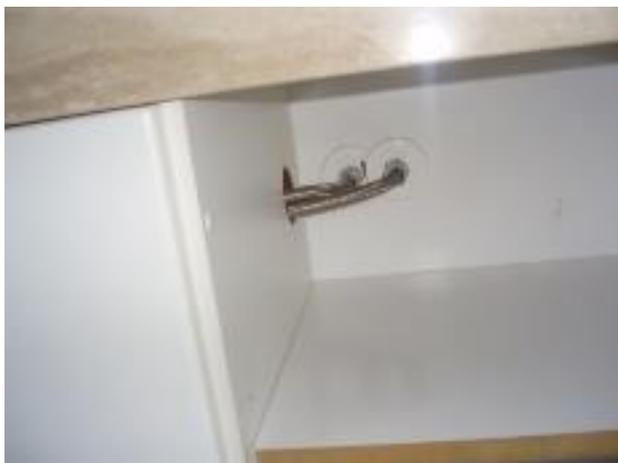
49. When I opened this vanity cupboard which backs onto the above mentioned wall I got a strong smell of fungus. There is likely to be decay to the timber framing of this wall.

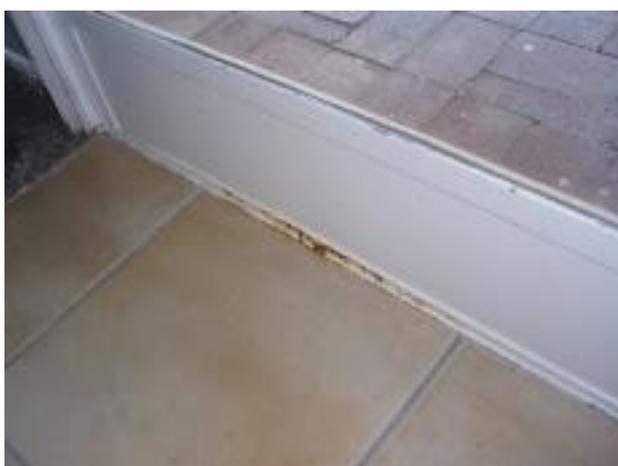
50. Rust is visible on the downstairs sliding door.

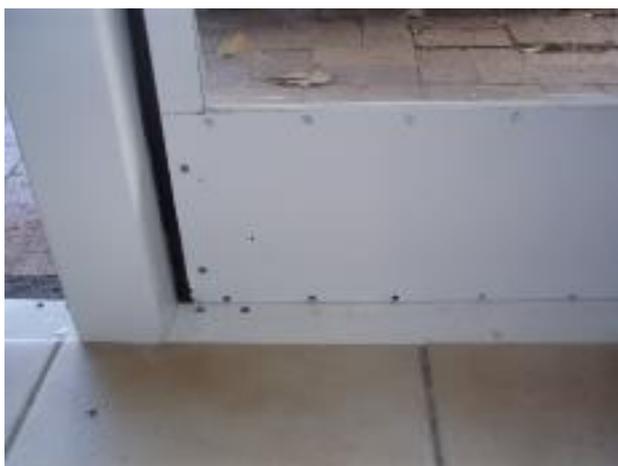
51. This door has had the original steel skin replaced.

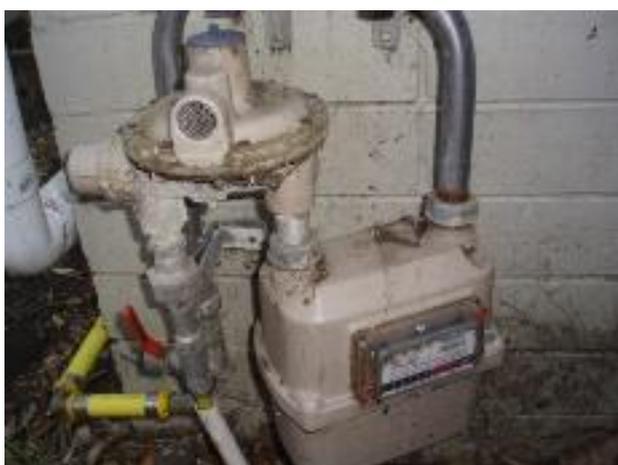
52. I could detect the smell of gas around the gas meter. It needs to be checked by a gas fitter.

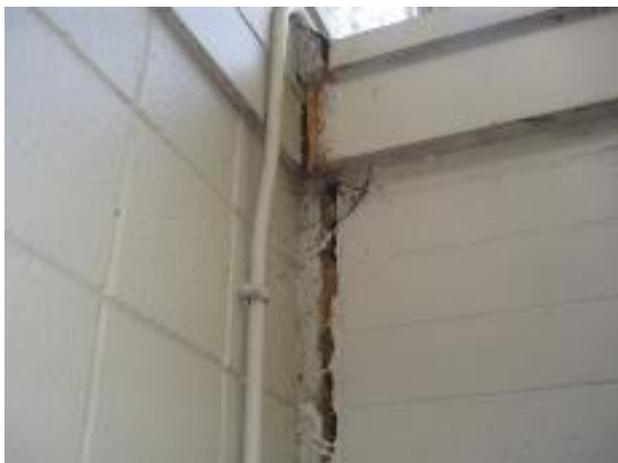
53. This is another view of the exterior of the garage cupboard.
