Jeff & Susan Wicks,
Parker Lane, R.D.2,
PUKEKOHE. 2677.

Ph/Fax : 09 2390123
Mob- Jeff : 0274 469909
Mob- Susan: 0274 469039

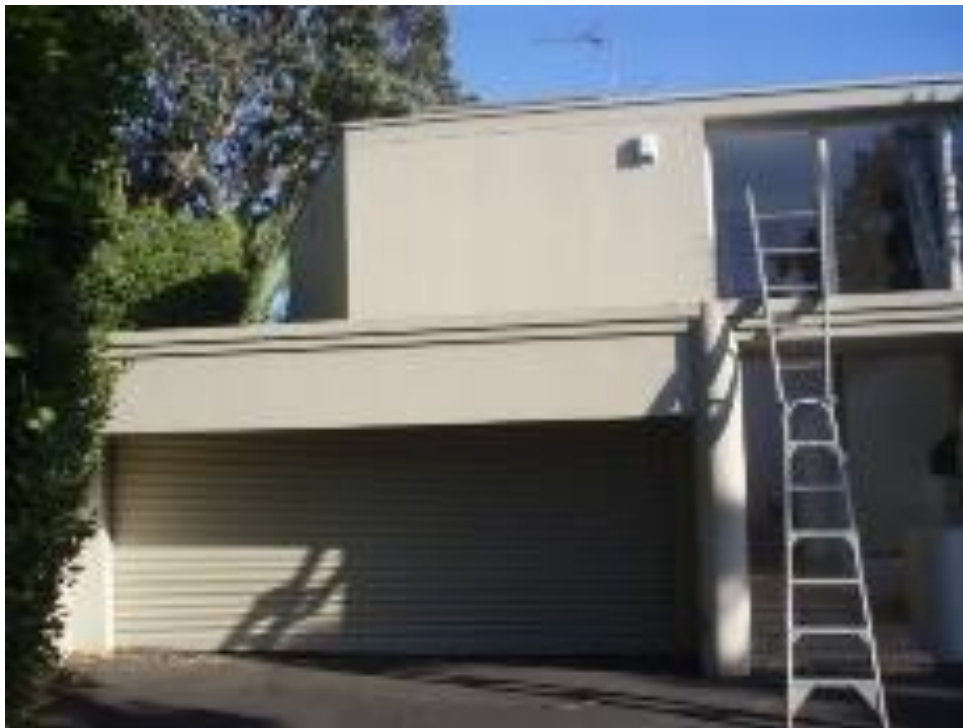
The subject house was originally built in the 1960's. It had composite cladding of concrete blocks, a stone feature wall & vertically clad cedar. The original windows are steel framed & the building relies on square hollow section portals at approx. 12ft (4 metre) centres.

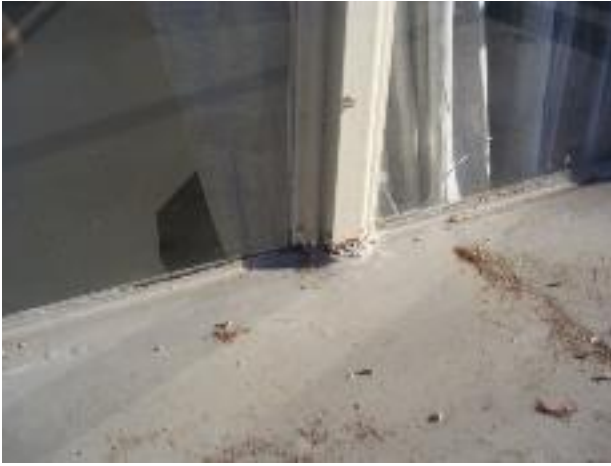
1. Here above the back door the butynol roof finishes against glass. This is a junction that is difficult to finish properly & must require constant maintenance.

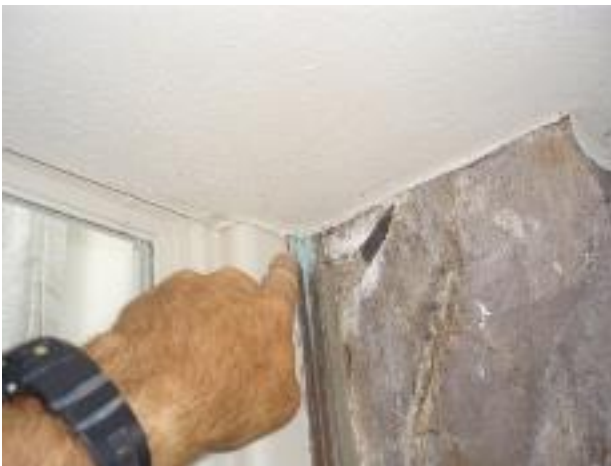
3. This is below the above mentioned junction. You can see water staining on the copper flashing.

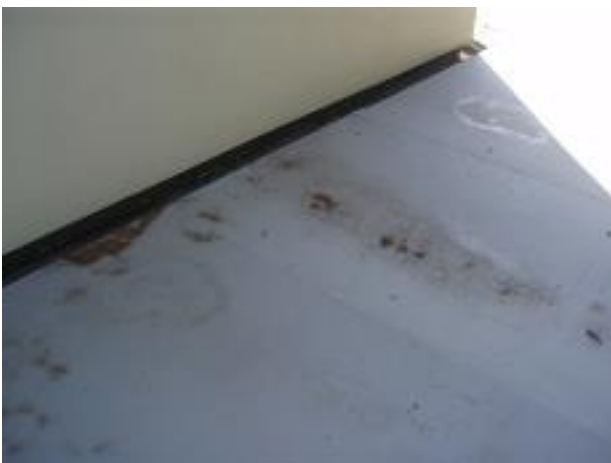
4. On the Western side of the lower flat roof there is an area where the substrate moved from the weight of me walking on it. This may be due to decay of the substrate.

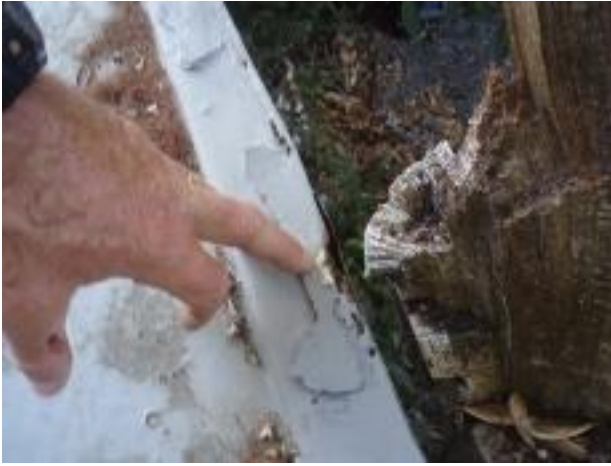
5. Here you can see a metal cap flashing on the Western edge of the lower butynol roof. It has rusted away & the paint on membrane has been applied over the remnants of it.

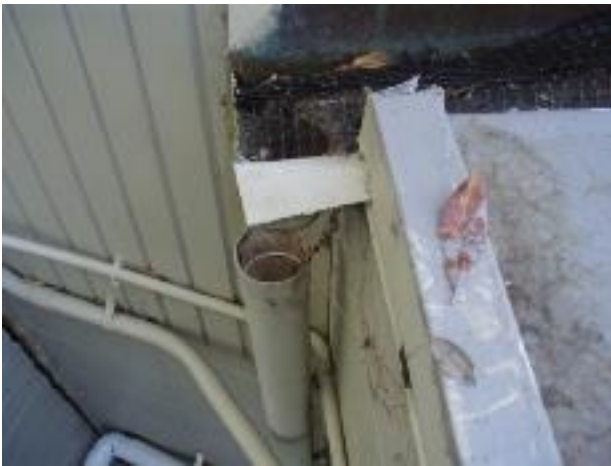
6. The down pipe to the lower roof is dislodged.

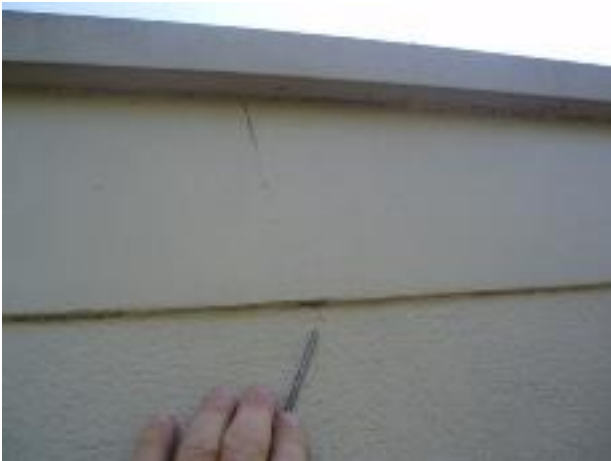
7. In places hairline cracks are visible in the EIFS cladding, particularly at this junction where the EIFS abuts the fascia board.

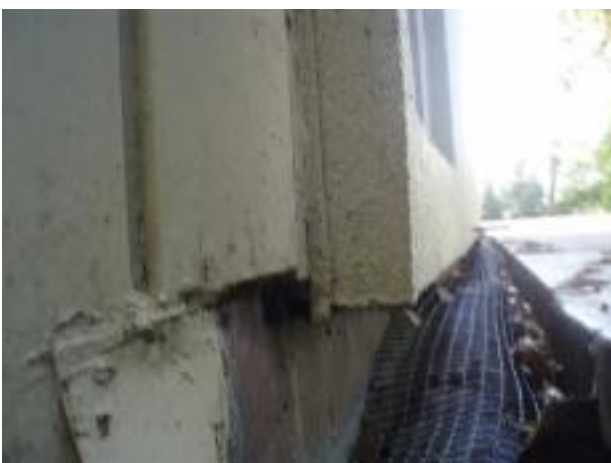
8. Here is a junction where you can see the original cedar cladding & the new EIFS. It appears that the EIFS has been clad directly over the cedar.

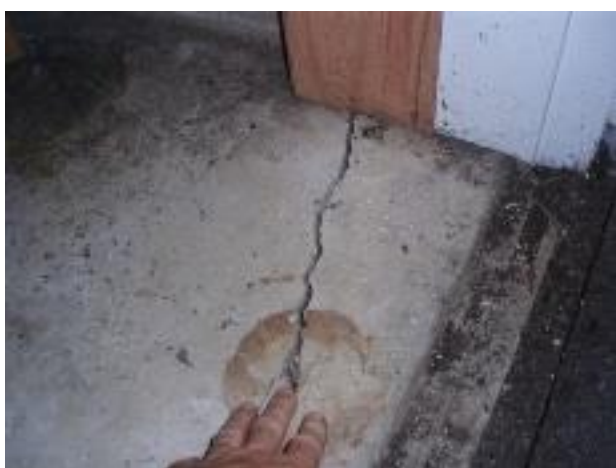
10. This shows the crack in the concrete floor. The floor has slumped noticeably.

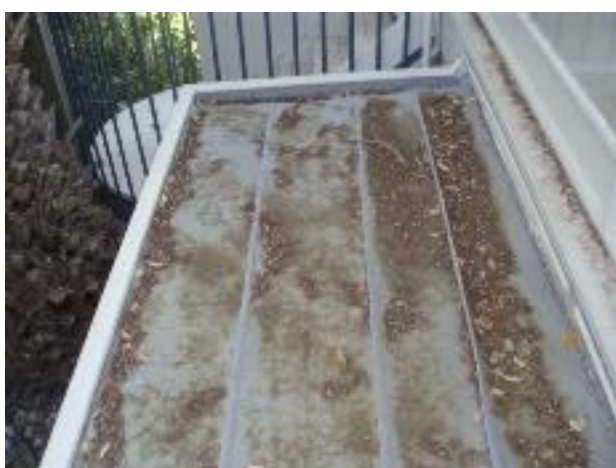
11. There is a lot of debris on the covered roof. It appears to leak & the gutter dropper (downpipe) is very small.

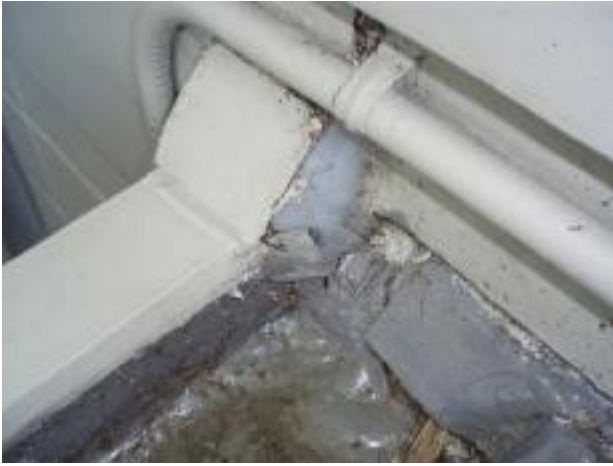
13. This junction of the cupboard roof to the cladding is not weathertight.

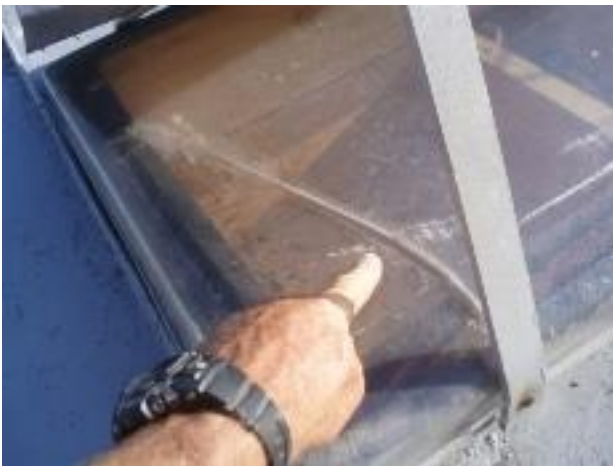
15. A broken skylight. This should be replaced ASAP.

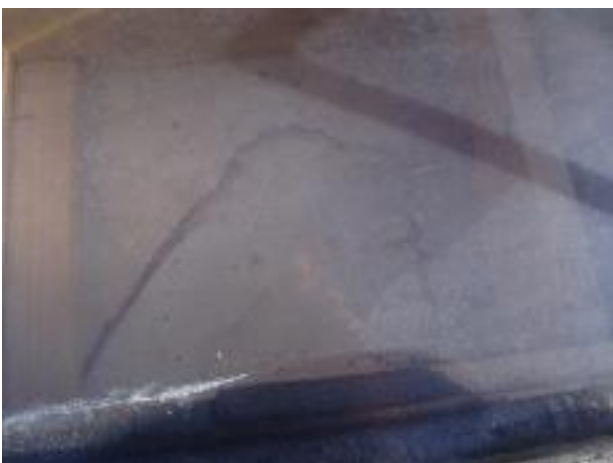
16. Waterstaining is visible on the gib board ceiling of the ensuite bathroom under the skylight. The leak is probably coming from the disused flue.

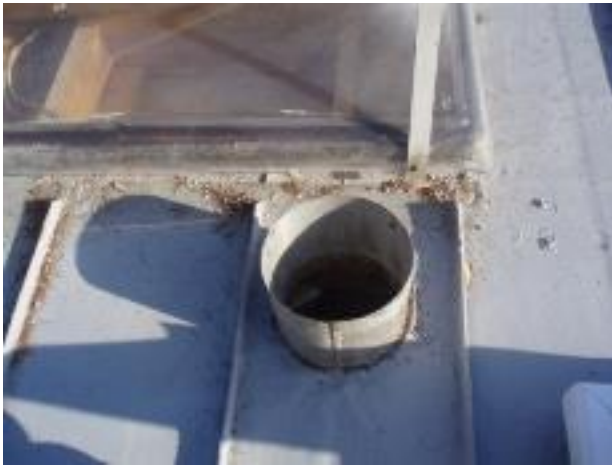
17. The disused flue.

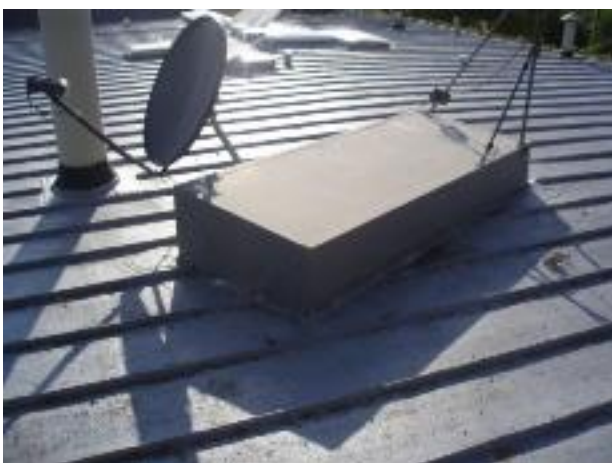
20. The roof has lots of penetrations & junctions. This is always a maintenance hassle on an old flat roof.

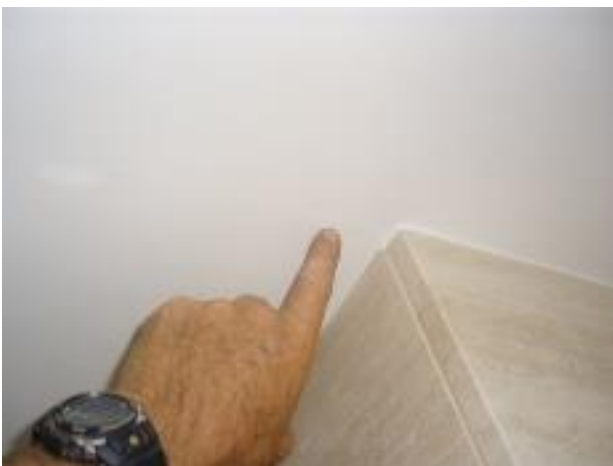
24. It is difficult to see in the photo but there is some damage to the gibboard ceiling below the skylight. See photo no. 16.

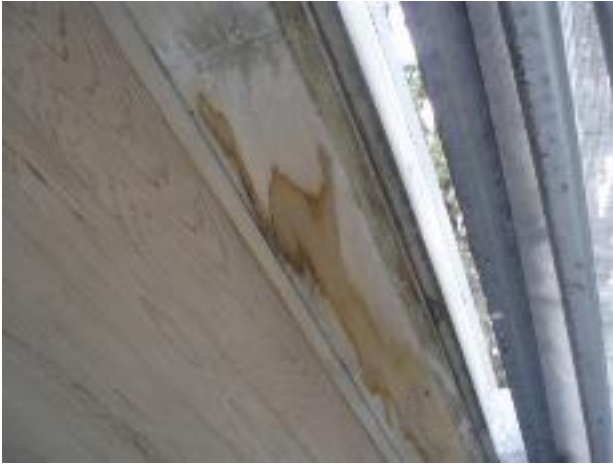
25. This waterstaining to the cedar soffit under the hidden gutter on the North wall is evidence of leaking.

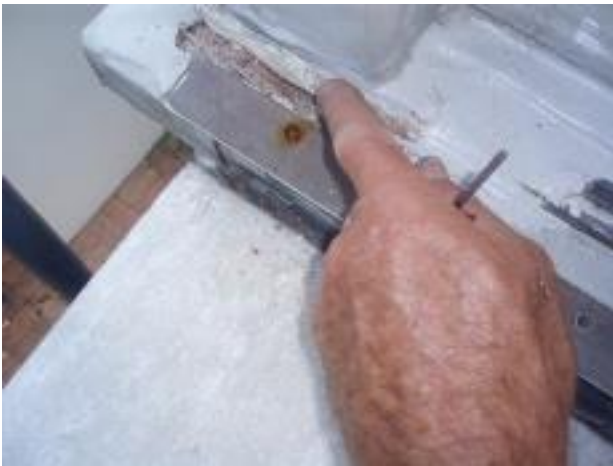
26. Water damage & corrosion is visible all along the base of the North wall.

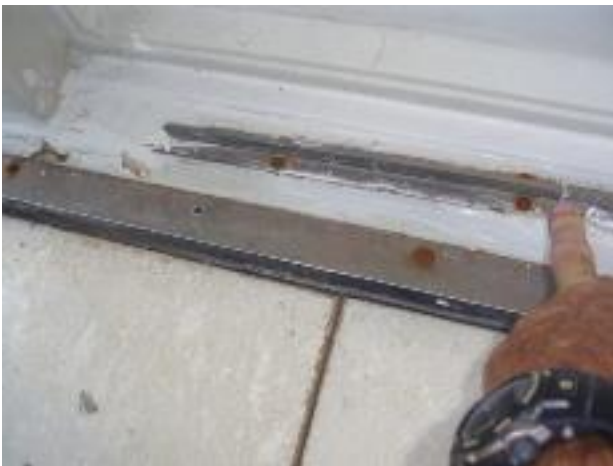
27. I took this photo to show that this area of the door track looked to be in poor condition....

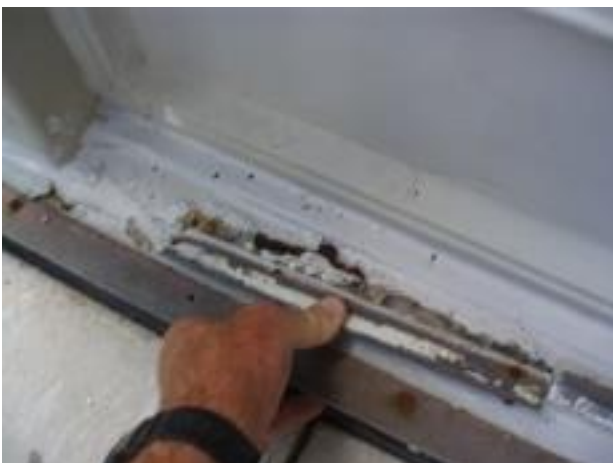
28...and a little later during the inspection I stood on it & it broke away.

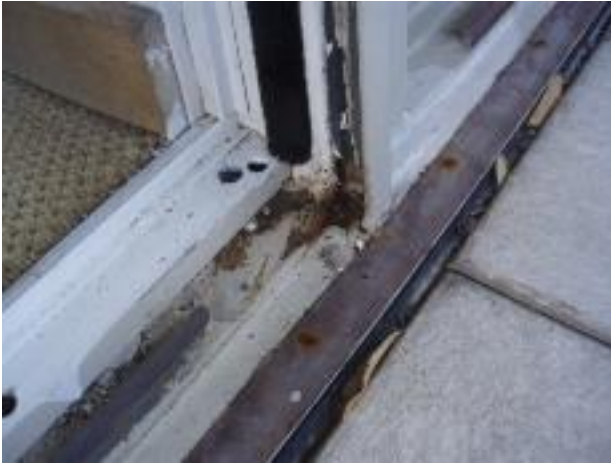
29. Another view of the door track of the North wall. Note the corrosion.

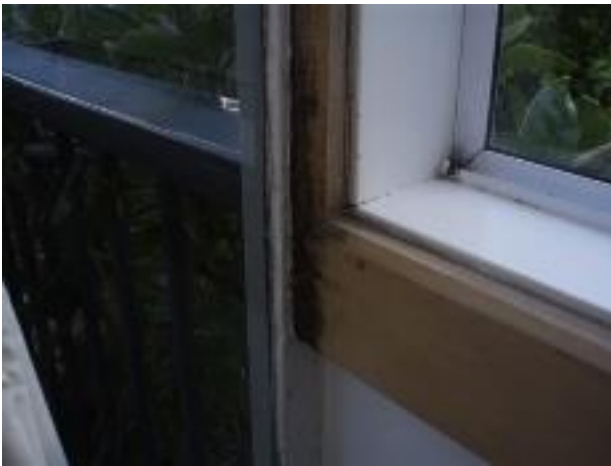
30. In the NE corner of the master bedroom the architrave of the window is discolored & moldy probably due to condensation around the steel window frame on the North wall.

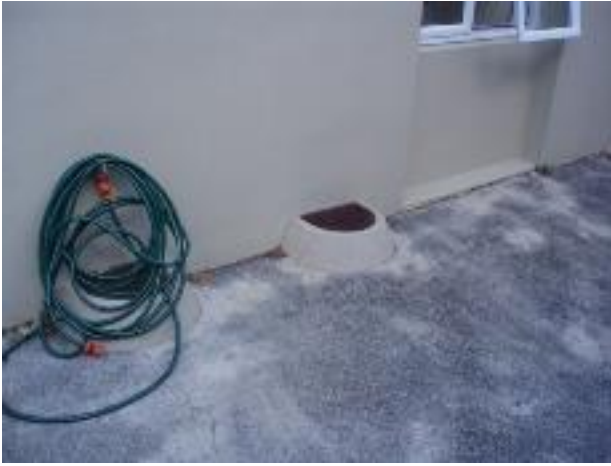
33. There are 2 gully traps on the Eastern wall. The overflow level of these appears to be higher than the lowest sanitary fixture – the downstairs shower. I recommend that the overflow level of these gullies be dropped.

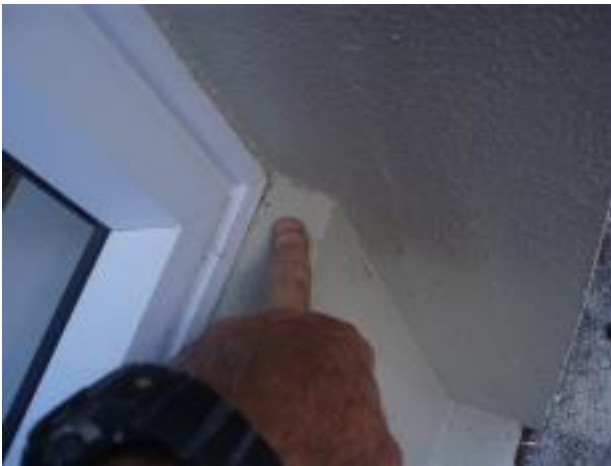
34. Small cracks are visible in the EIFS cladding on the Eastern wall.

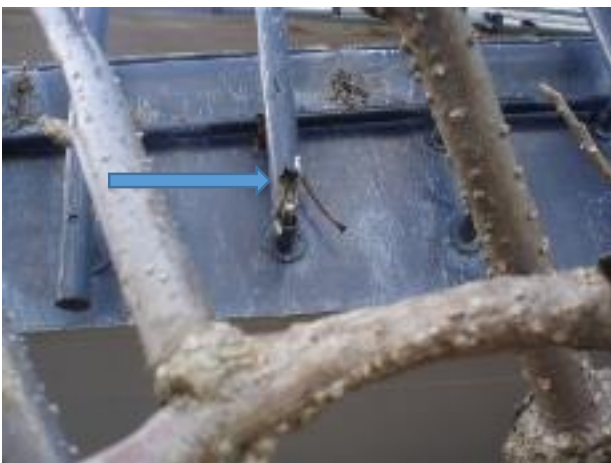
36. The handrail balusters are in poor condition. Several are broken away at the base.

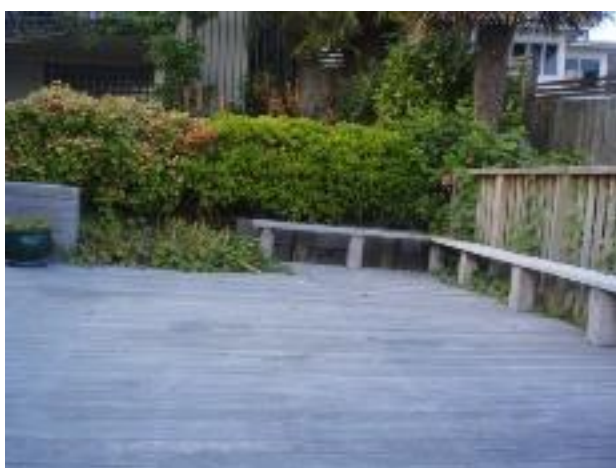
38. The timber deck at the rear of the property slopes noticeably down to the West. Presumably it was built level & ground movement is the reason.

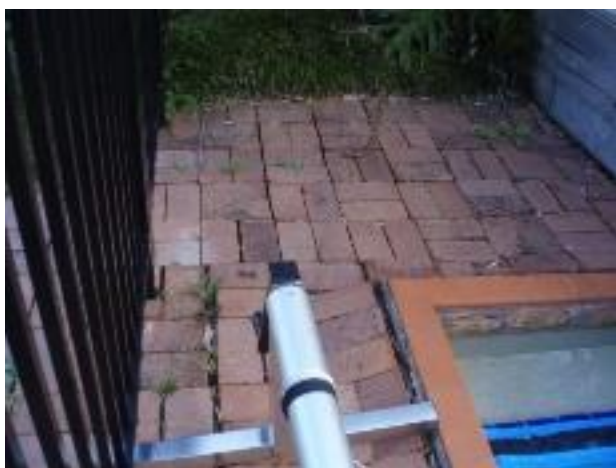
39. More evidence of ground movement in the landscaping around the pool. This is possibly due to loose fill not being properly compacted after the pool excavation.

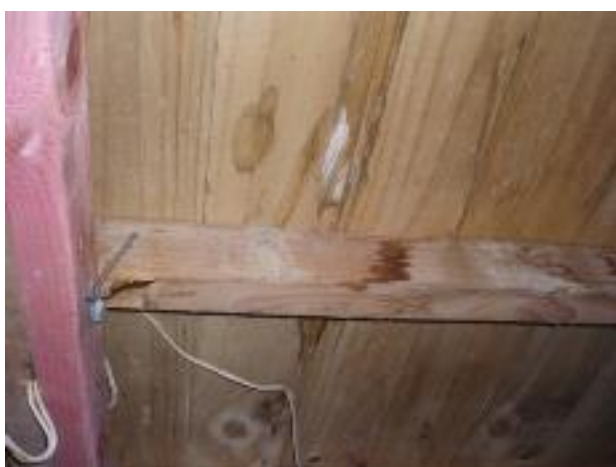
40. This is the ceiling of the cupboard off the garage. You can see that it leaks.

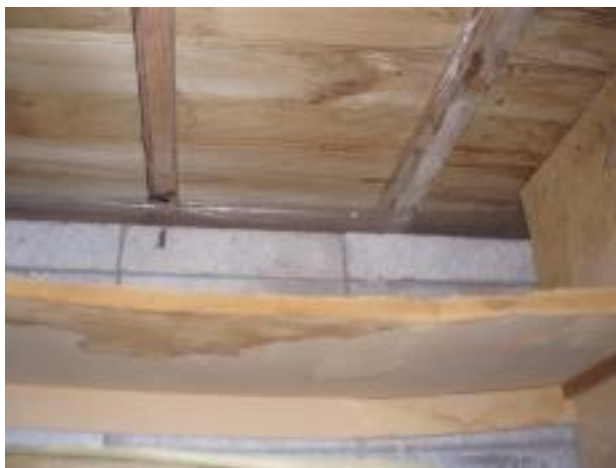
41. Another view of the cupboard ceiling.

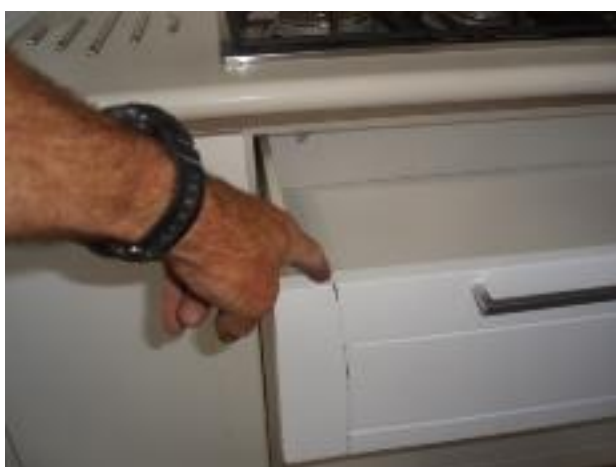
44. The drawer front has had a knock & the damaged portion glued back on.

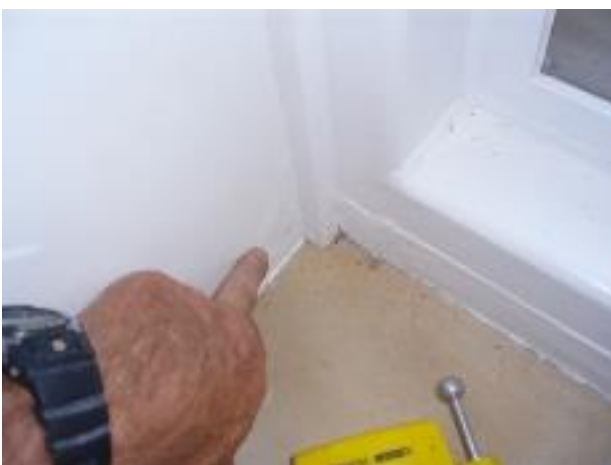
48. Water damage is visible on the gibboard wall in the entry lobby. The water ingress here may well stem from the steel portal highlighted in photo 2 & 3.

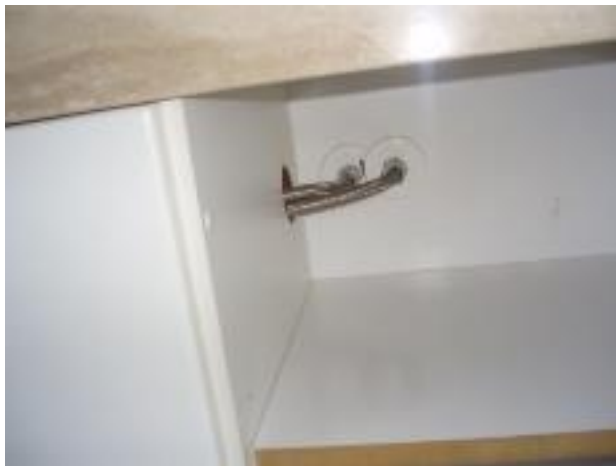
49. When I opened this vanity cupboard which backs onto the above mentioned wall I got a strong smell of fungus. There is likely to be decay to the timber framing of this wall.

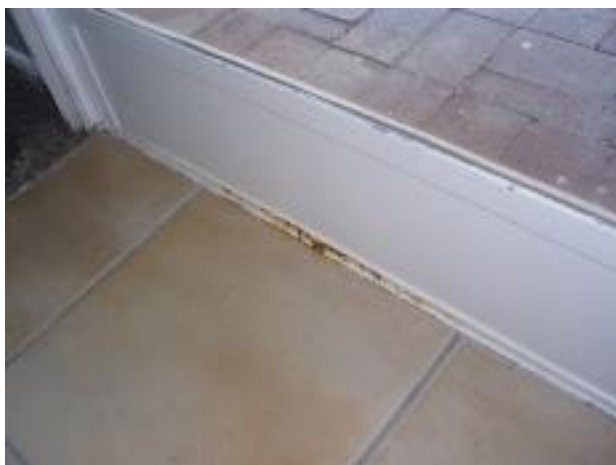
50. Rust is visible on the downstairs sliding door.

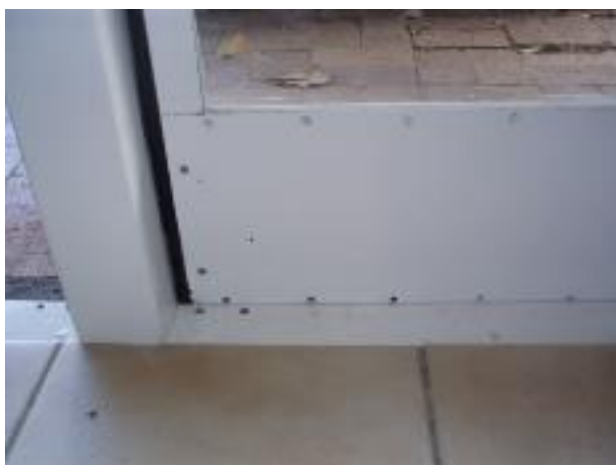
51. This door has had the original steel skin replaced.

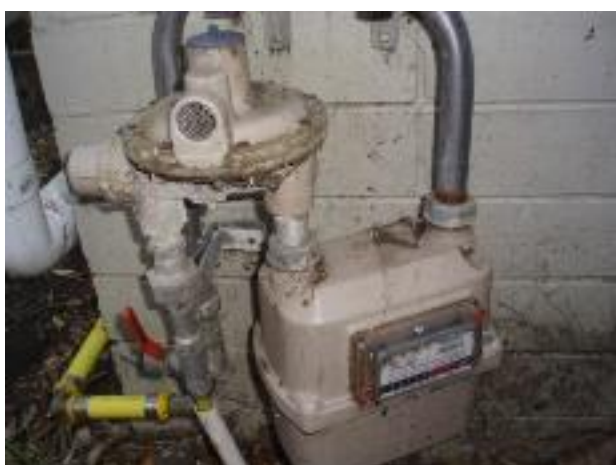
52. I could detect the smell of gas around the gas meter. It needs to be checked by a gas fitter.
