Jeff & Susan Wicks,  
Parker Lane, R.D.2,  
PUKEKOHE. 2677.

Ph/Fax : 09 2390123  
Mob- Jeff : 0274 469909  
Mob- Susan: 0274 469039

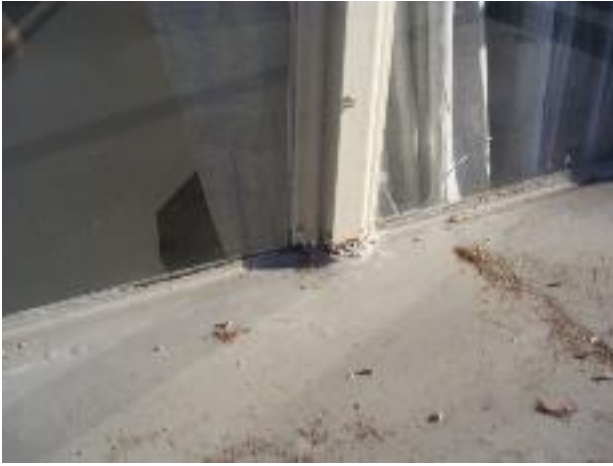
1. Here above the back door the butynol roof finishes against glass. This is a junction that is difficult to finish properly & must require constant maintenance.

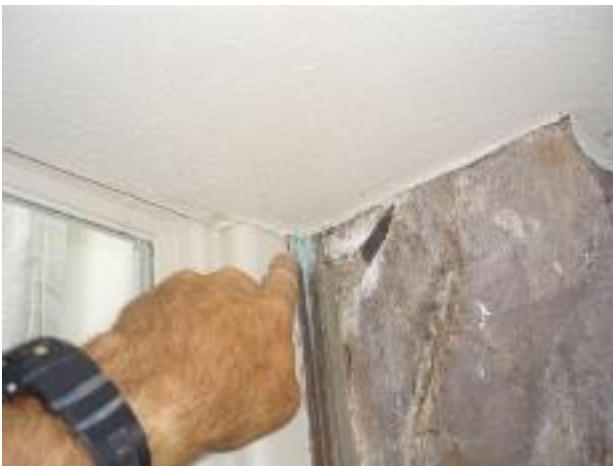
3. This is below the above mentioned junction. You can see water staining on the copper flashing.

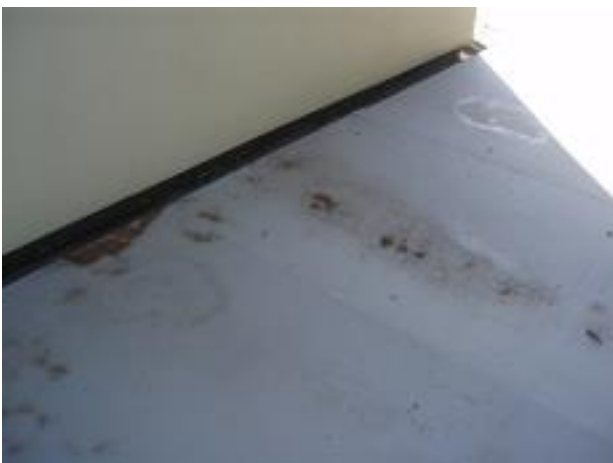
4. On the Western side of the lower flat roof there is an area where the substrate moved from the weight of me walking on it. This may be due to decay of the substrate.

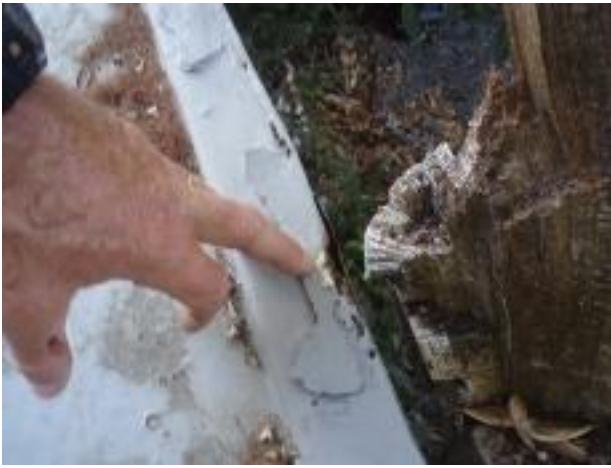
5. Here you can see a metal cap flashing on the Western edge of the lower butynol roof. It has rusted away & the paint on membrane has been applied over the remnants of it.

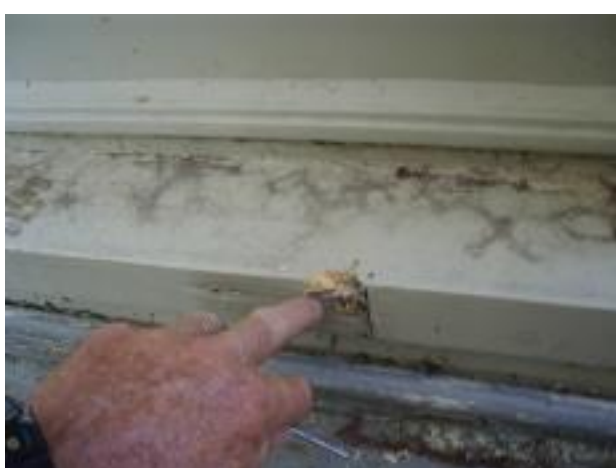
12. A decayed window sill on the Western wall of the lounge.

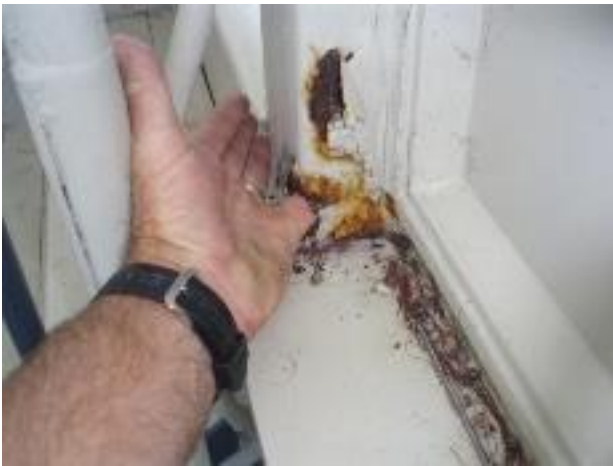
14. This shows severe corrosion of the SHS portal on the NW corner. You can see I have pushed my finger through the rust.

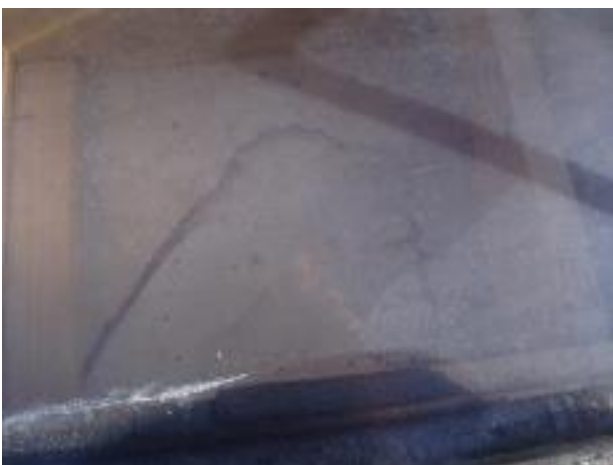
16. Waterstaining is visible on the gib board ceiling of the ensuite bathroom under the skylight. The leak is probably coming from the disused flue.

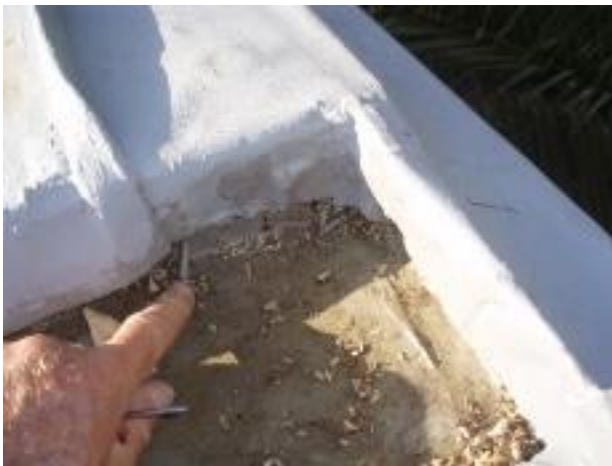
19. The entire roof has been covered with a paint on membrane but not a lot of attention was paid to detail & prep work. As an example I am pointing to a screw that was lying loose in the guttering & simply painted over.

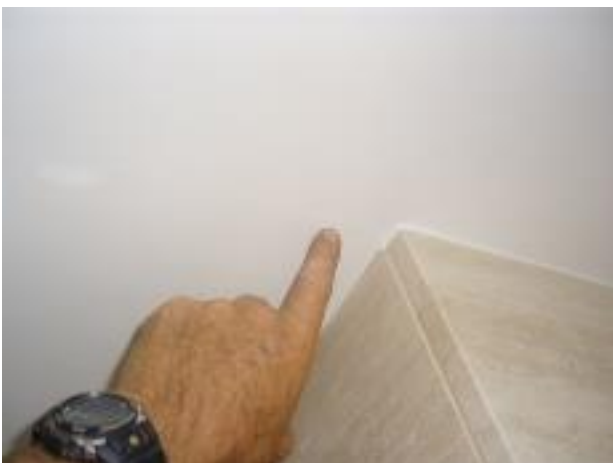
24. It is difficult to see in the photo but there is some damage to the gibboard ceiling below the skylight. See photo no. 16.

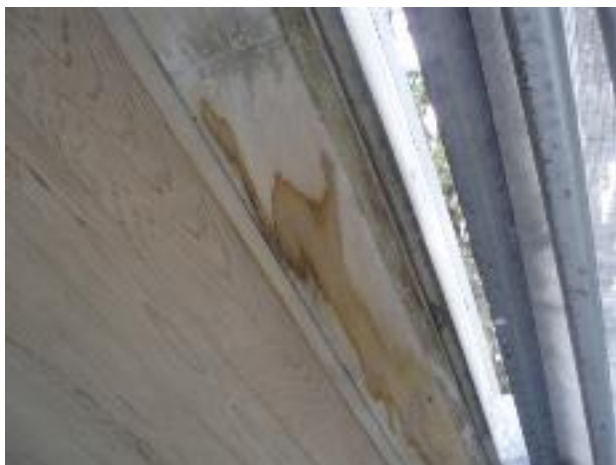
25. This waterstaining to the cedar soffit under the hidden gutter on the North wall is evidence of leaking.

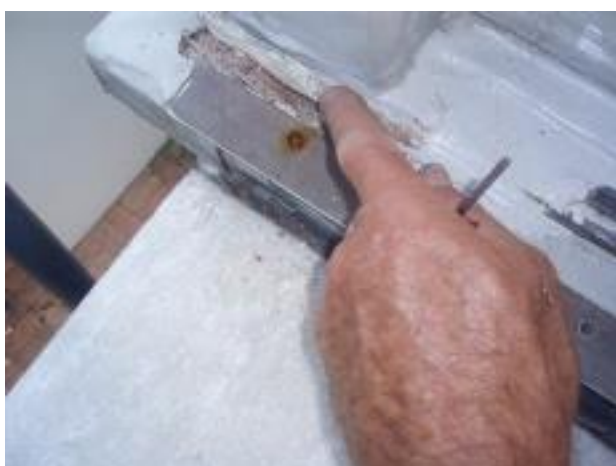
26. Water damage & corrosion is visible all along the base of the North wall.

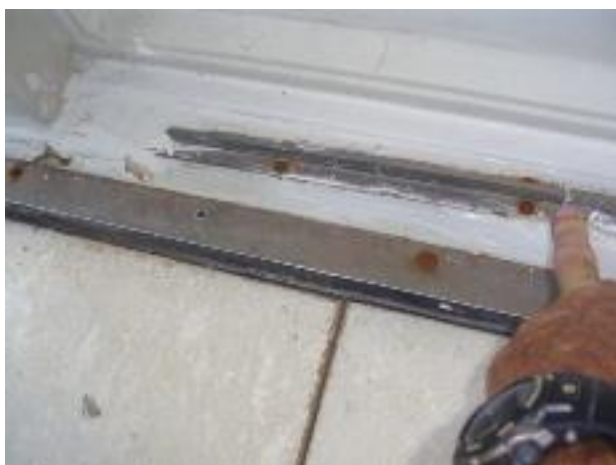
27. I took this photo to show that this area of the door track looked to be in poor condition....

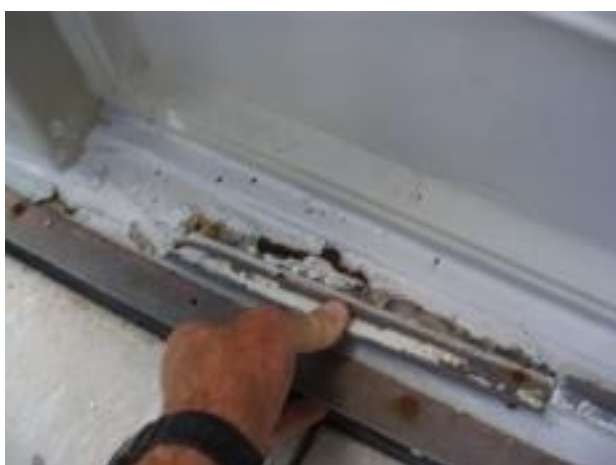
28...and a little later during the inspection I stood on it & it broke away.

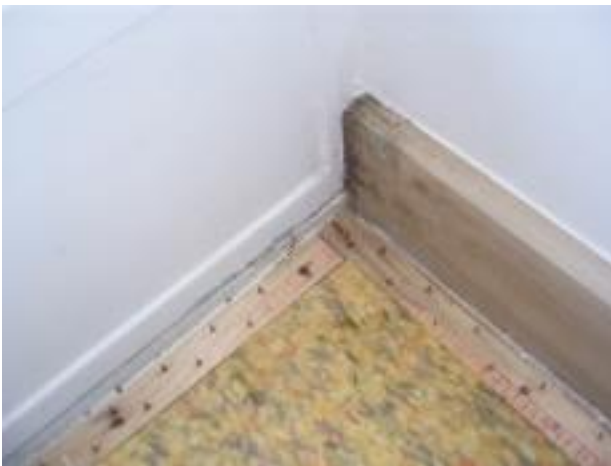
31. The same thing is visible on the skirting board directly below it. Again probably due to the condensation on the joinery unit. I received slightly elevated moisture readings in this location.

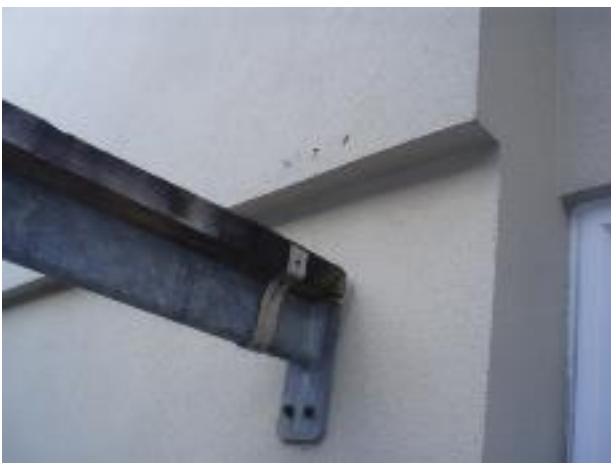
32. Water ingress likely occurs where this gate structure is bolted to the EIFS cladding. Also note the holes drilled in the cladding above the gate structure. They are not stopped up.

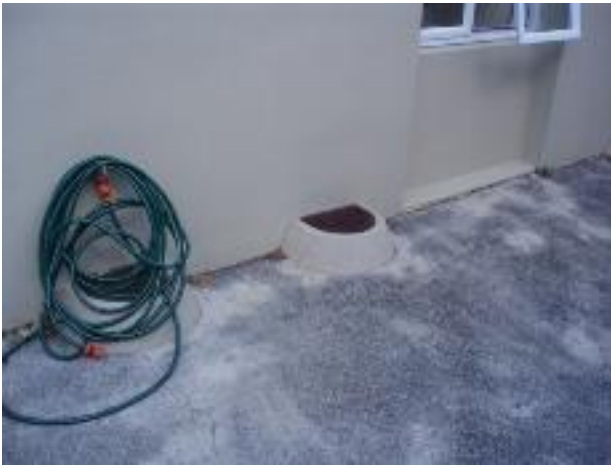
33. There are 2 gully traps on the Eastern wall. The overflow level of these appears to be higher than the lowest sanitary fixture – the downstairs shower. I recommend that the overflow level of these gullies be dropped.

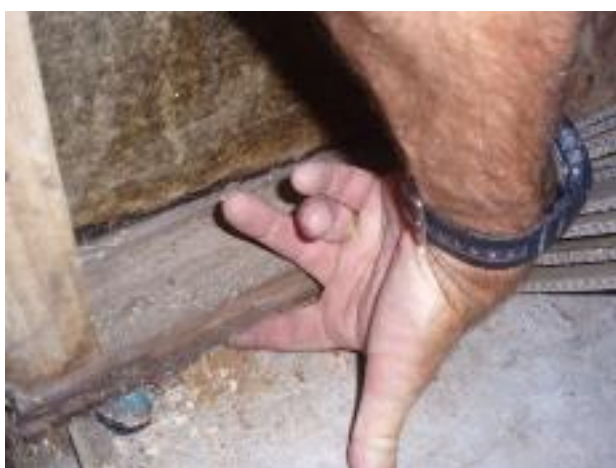
42. The bottom plate of the cupboard is severely decayed.

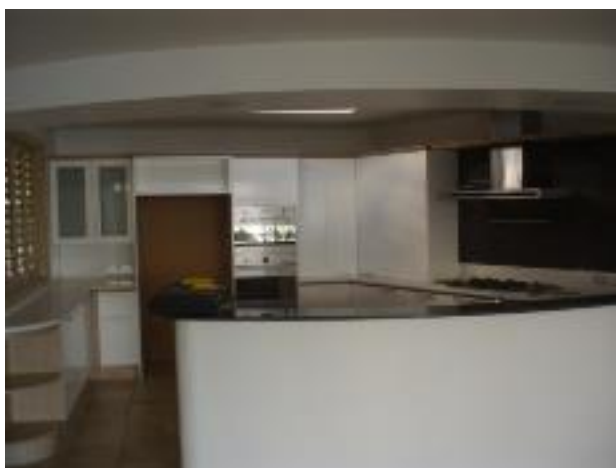
43. The kitchen looks to be of good quality & well installed. The cabinet fronts would have originally had a timber finish but they have now been painted over. I'll comment further in my summary.

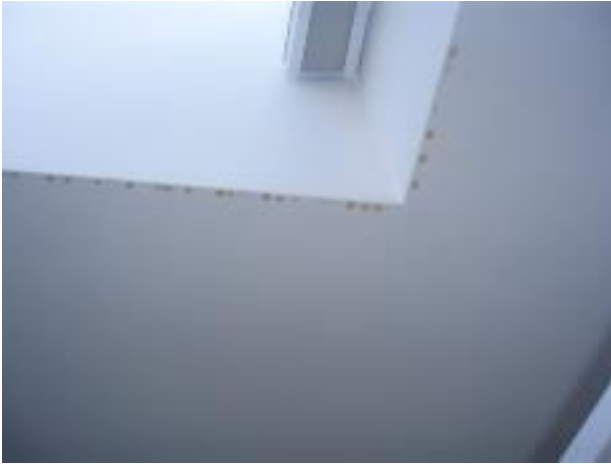
45. The discoloration around the edge of the skylight is caused by condensation / leaking.

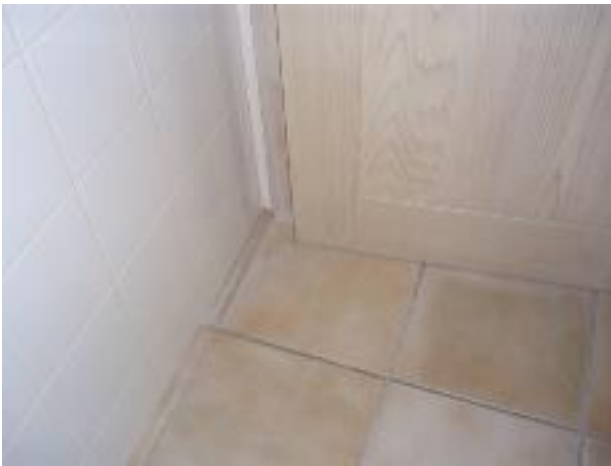
46. The toilet door binds on the floor, I think due to substrate movement.

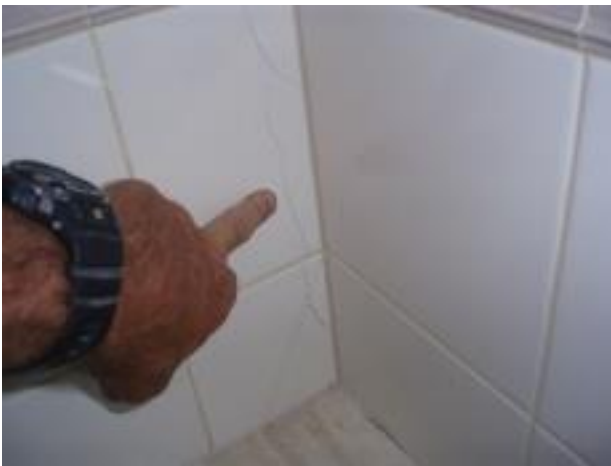
47. These cracked tiles, also in the bathroom, are probably also due to substrate movement.

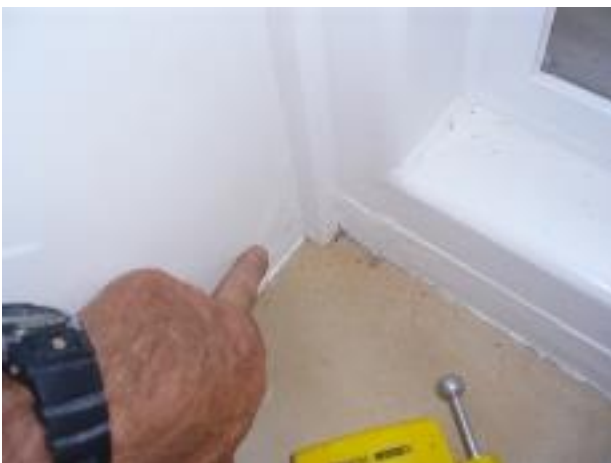
48. Water damage is visible on the gipboard wall in the entry lobby. The water ingress here may well stem from the steel portal highlighted in photo 2 & 3.

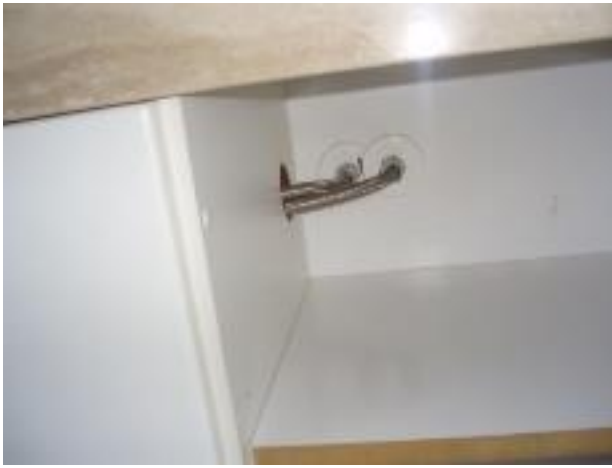
49. When I opened this vanity cupboard which backs onto the above mentioned wall I got a strong smell of fungus. There is likely to be decay to the timber framing of this wall.

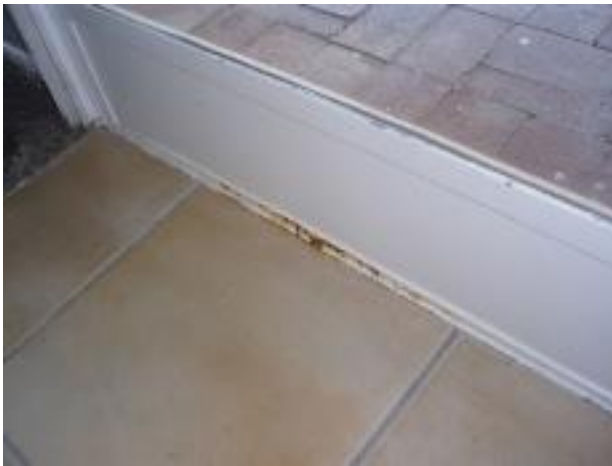
50. Rust is visible on the downstairs sliding door.

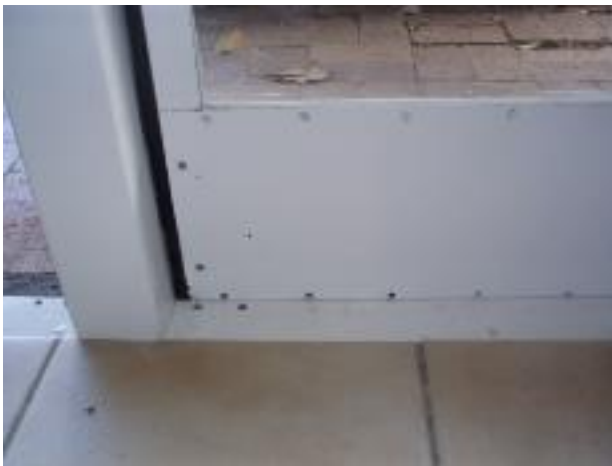
51. This door has had the original steel skin replaced.

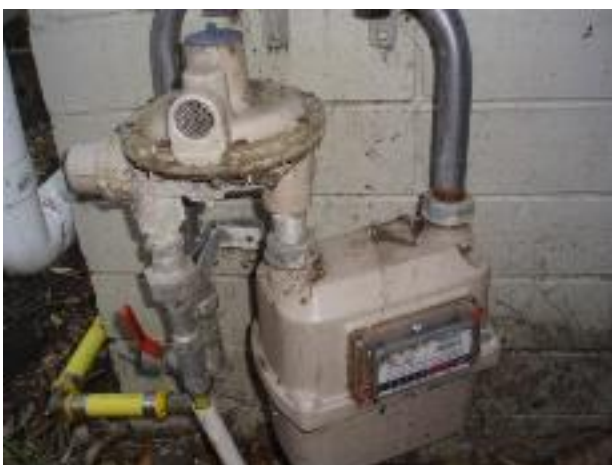
52. I could detect the smell of gas around the gas meter. It needs to be checked by a gas fitter.
