Jeff & Susan Wicks,
Parker Lane, R.D.2,
PUKEKOHE. 2677.

Ph/Fax : 09 2390123
Mob- Jeff : 0274 469909
Mob- Susan: 0274 469039

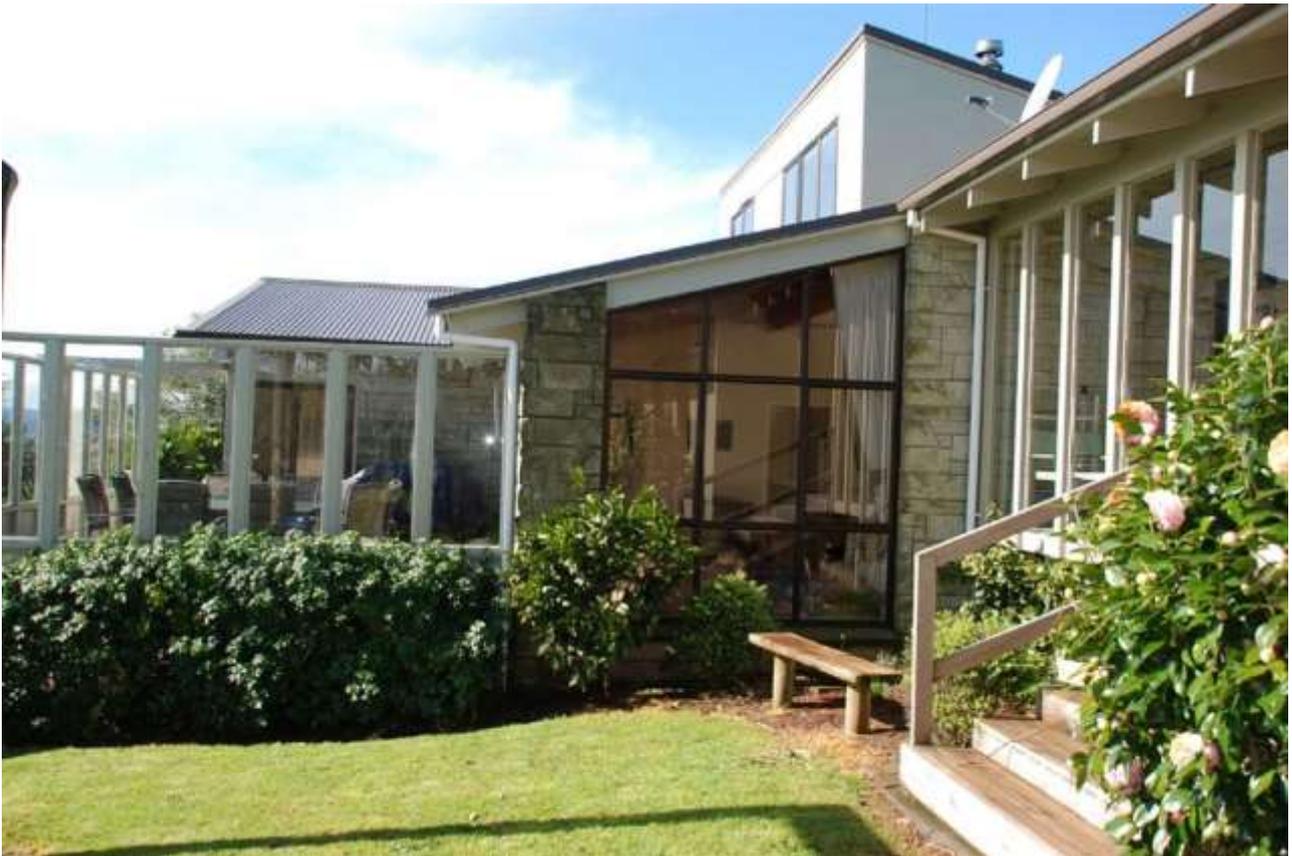
The subject house was built in the 1980's. It has composite cladding of Hinuera Stone, texture coated fibre light & plywood to the North facing high lights. The LIM report indicates a permit was issued for the construction of the house in 1984 & a dwelling extension permit issued in September 1991 – I believe this to be for the garage & rumpus room. Consent was obtained for a solid fuel heater & a Code of Compliance Certificate was issued in August of 2009. The property is in a location which is subject to rural plan change 14. See the link following:

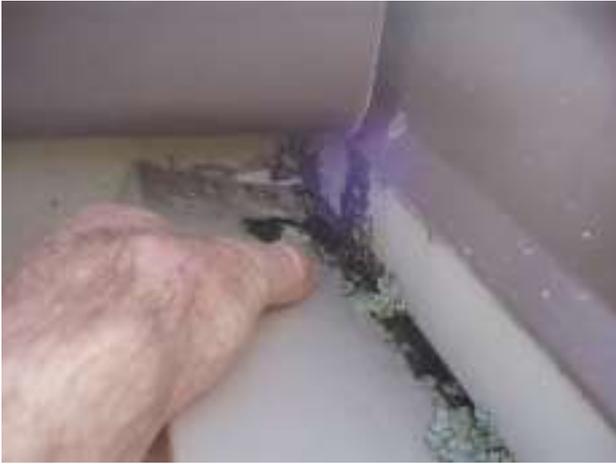
1. In many places the roof does not have a significant eaves overhang & here above the ensuite bathroom the roof stops short of the building line & there is a flashing which laps over the cladding & under the barge board. This is a dangerous detail & the top edge of the flashing where it butts to the fascia is highly likely to be a leak point.

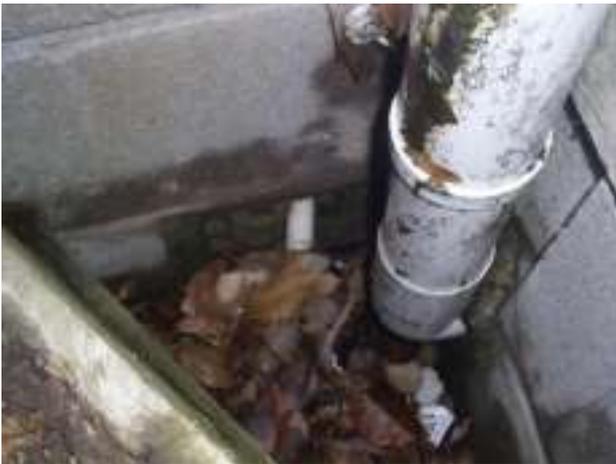
2. I assume the small pipe that protrudes through the basement wall to be the ensuite toilet cistern overflow. There is no gully trap here so in the event that it works for any length of time it will be a source of dampness.

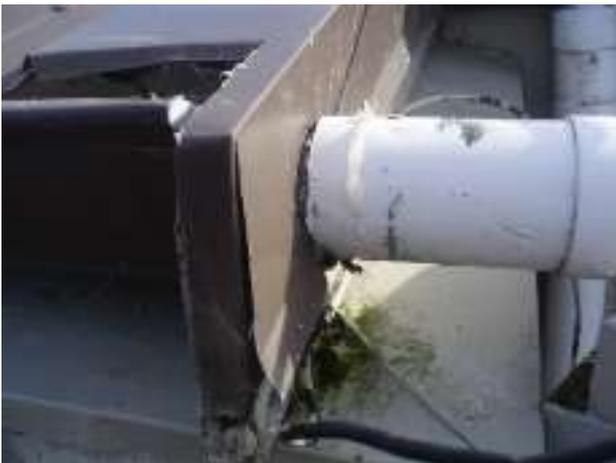
3. This is an unsatisfactory arrangement. The spouting outflow is through a "Jerry Built" spouting stopend. It leaks & it is located above this high risk flashing detail.

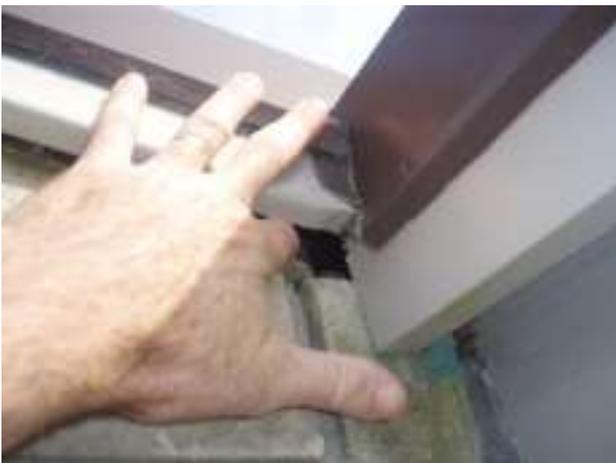
4. Near the NE corner of the house the fascia does not extend low enough to provide adequate cover to the top of the Hinuera stone cladding.

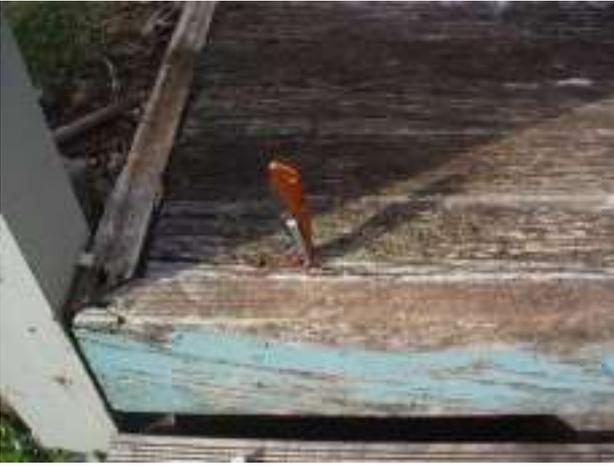
5. This is the decking in the NE corner. This particular board is very decayed & should be replaced. The decking generally is old & is at the stage where it needs to be fully re-planked. Otherwise you run the risk of the planking breaking & someone potentially getting hurt. You can see here I pushed a knife blade right through the decking.

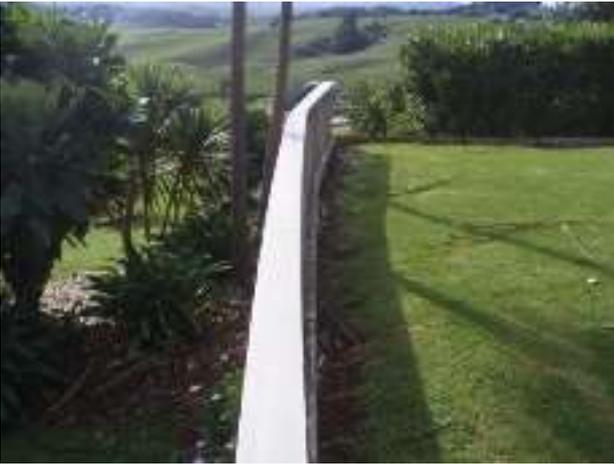
6. The landscaped retaining wall to the East of the house has rotated quite significantly its construction is slender given its height.

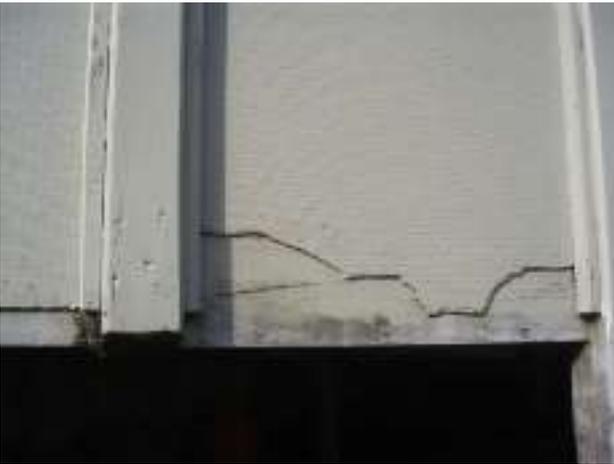
7. A lot of the fibrolite panels of the deck balustrade / windbreak are broken & due for repair.

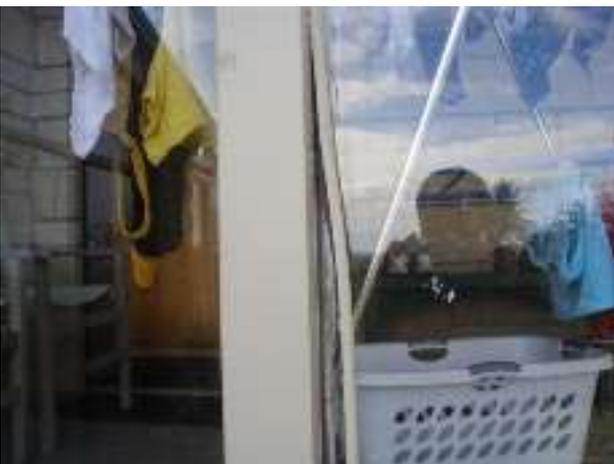
8. There is a lot of maintenance required to these wind breaks. They are in quite a poor state of repair. Everywhere you look there is maintenance to be done. This shows a glazing bead has come loose.

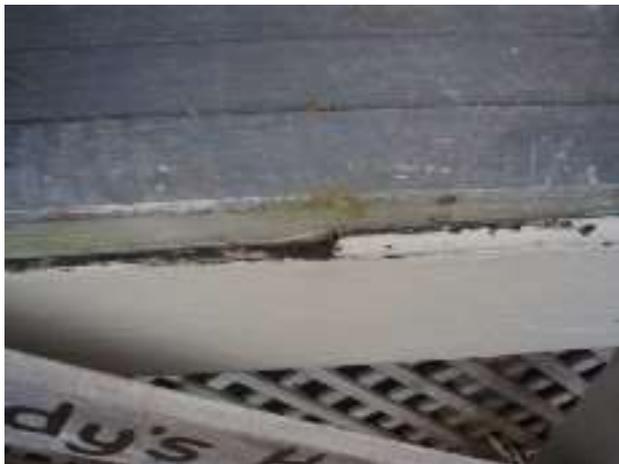
9. This one shows a glazing bead which is decayed & partially missing.

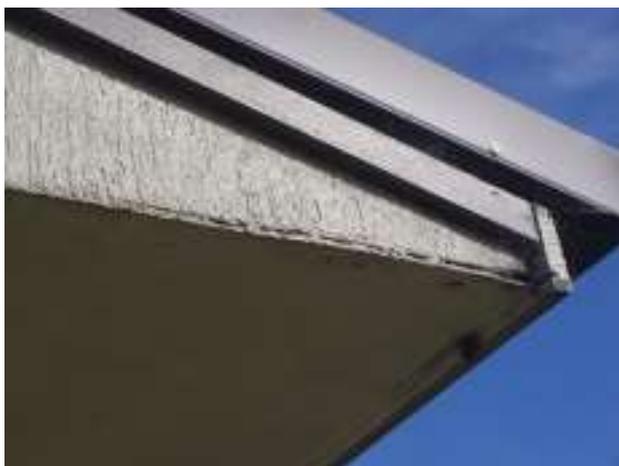
10. This is the eaves overhang at the NE corner of the garage. The soffit lining extends past the gable end cladding so obviously water enters the building envelope here. I'm sure if you were able to see the soffit framing some decay would be present.

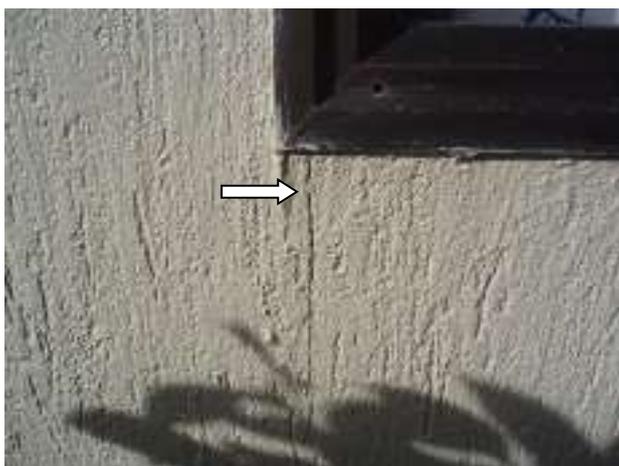
11. All around the house are these sorts of cracks in the textured coating. These are all water ingress points.

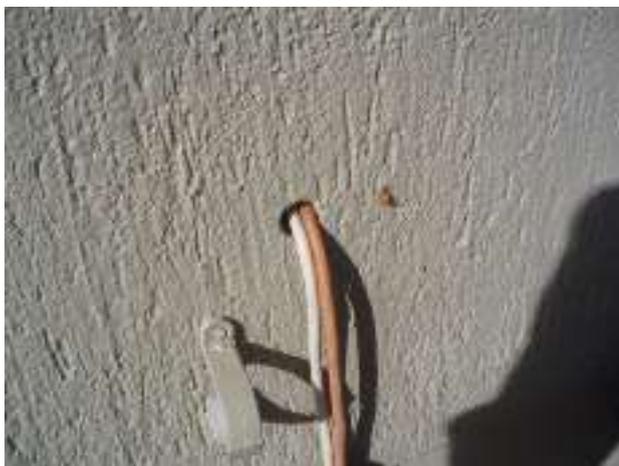
13. This electrical cable penetration is not well sealed so is a point of water ingress.

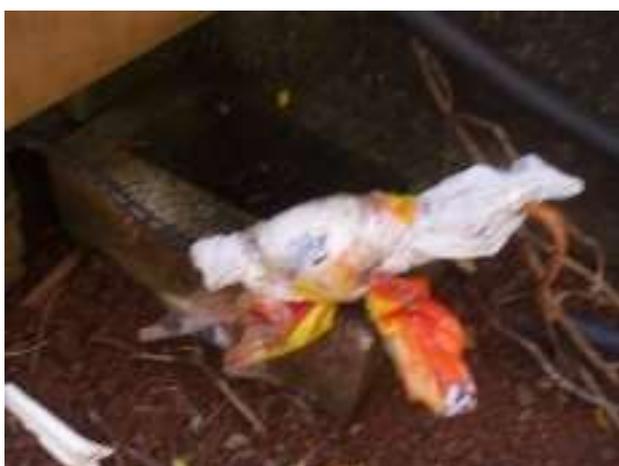
14. This is the method of water proofing the plug to the water pump. Old plastic bags have been wrapped around it. This should be fixed.

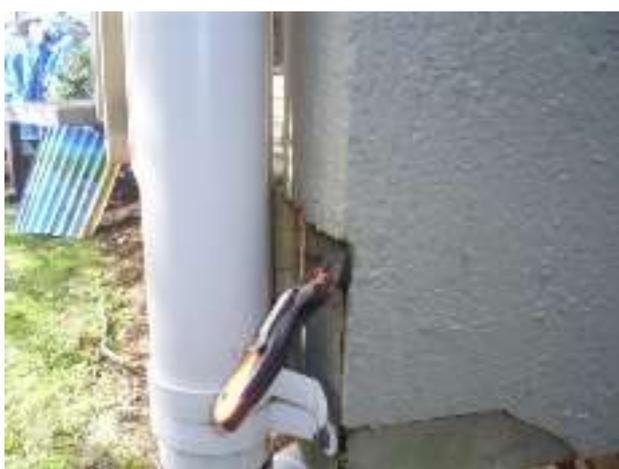
15. This is the NW corner of the garage. I was easily to push my pocket knife into the decayed bottom plate here.

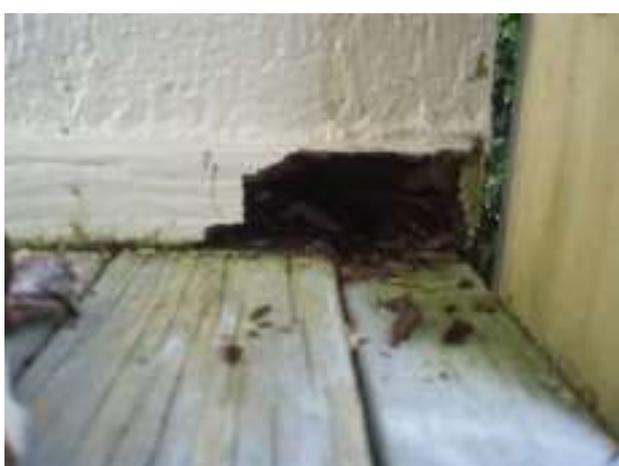
16. This is the same location viewed from the Eastern side. The timber trim is friable, as is the baseplate.

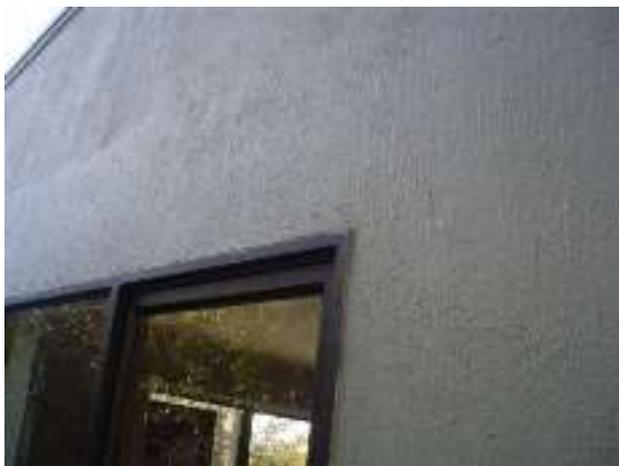
17. This is the Western gable of the garage. There is no head flashing here & no doubt that this leaks. Observe the uneven cladding above the window. This is often a sign of a leaky wall.

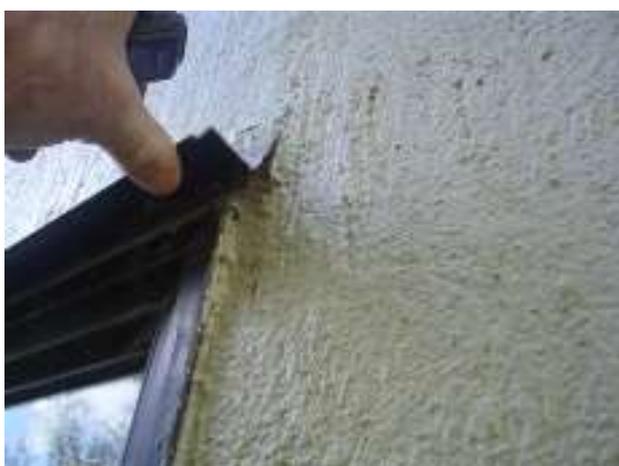
18. This is the floor to ceiling window on the West wall of the garage. There is evidence of leaks being chased around here & someone has planted this head flashing on top of the cladding. That is an unsatisfactory solution.

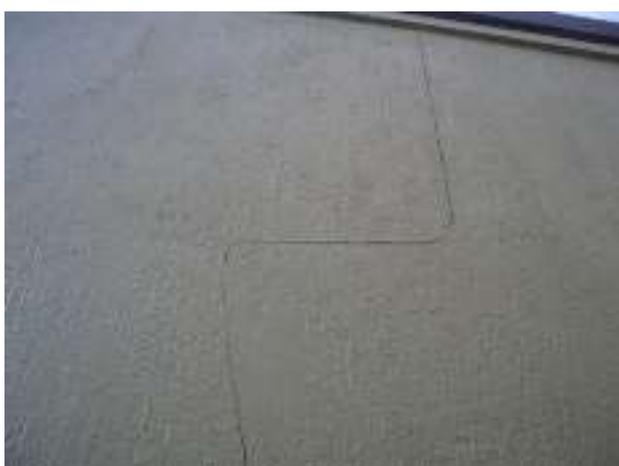
19. This crack in the cladding extends from the top LHS of the floor to ceiling window up to the fascia board. This is a definite leak.

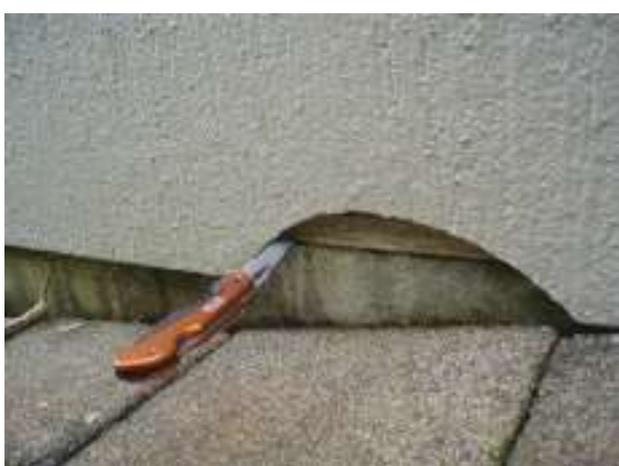
20. Cladding is broken at baseplate level & reveals the timber baseplate in the early stages of decay.

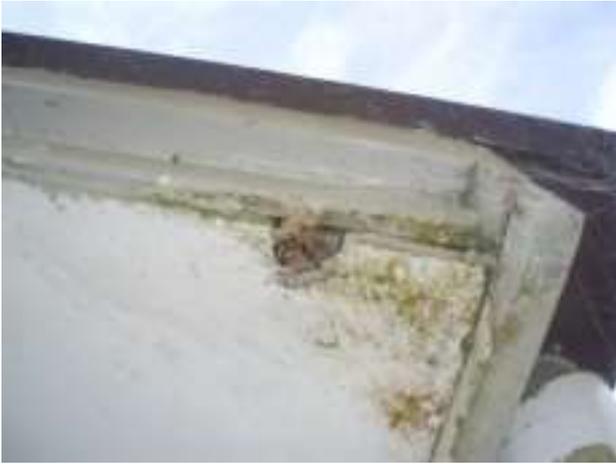
21. This is the SW corner of the eaves. This definitely leaks.

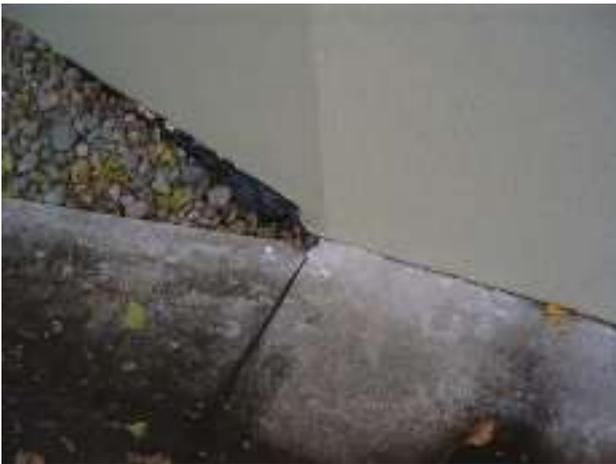
22. The South wall of the garage & rumpus room has cladding which extends below the adjacent ground level. This is a very bad detail which inevitably leads to trapped moisture & decay.

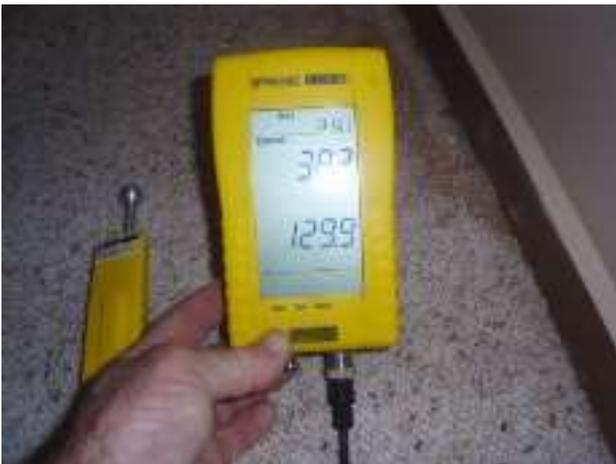
23. In the rumpus room all along the West wall & the South wall I got significantly elevated moisture readings. Here I am showing the moisture meter with a reading of 129.9.

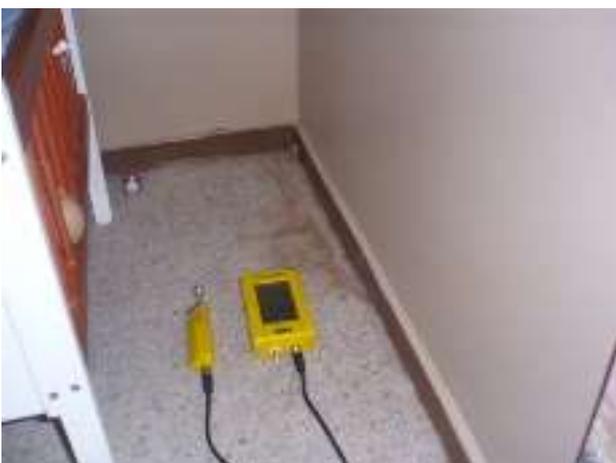
24. Water staining is clearly visible on the carpet in the SW corner of the rumpus.

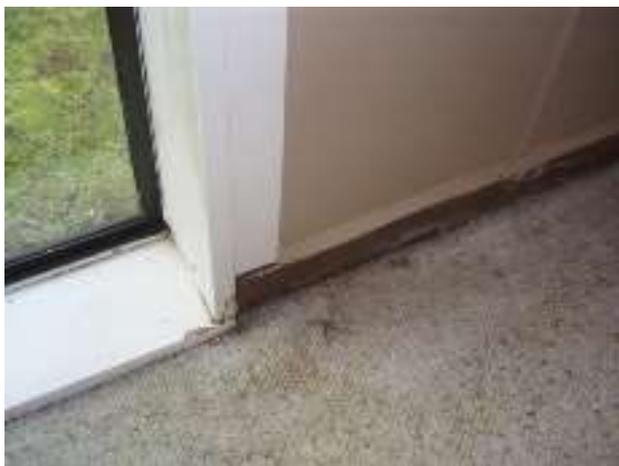
25. This is a typical view of the skirting. It is “blown “& water damage is clearly visible.

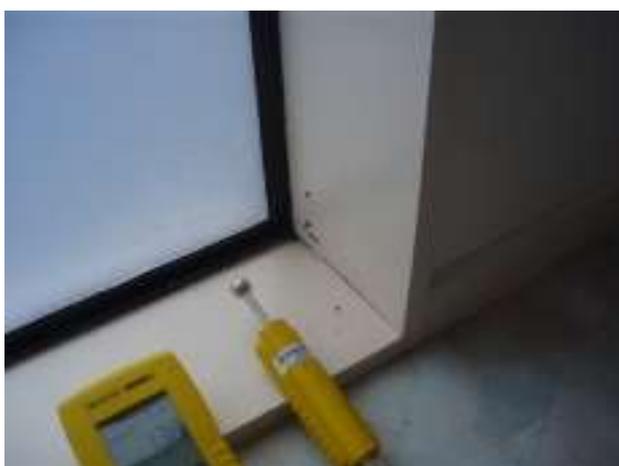
26. On the RHS of the floor to ceiling window in the ensuite bathroom I got an elevated reading of 77 & you can see the bottom side of the window liner is “blown”.

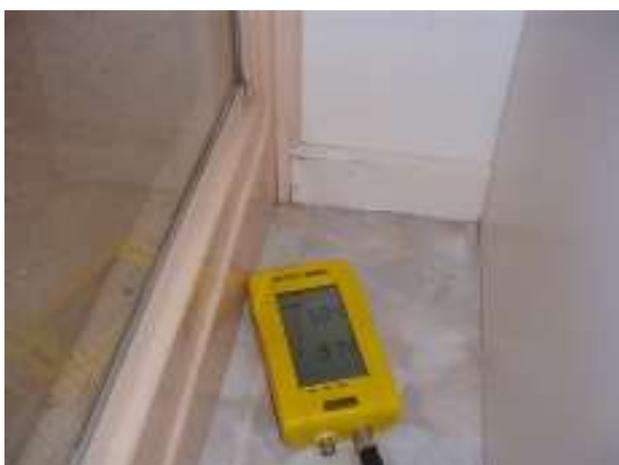
28. On the skirting board at the RH corner of the shower cubicle in the en suite the skirting board shows visible signs of moisture damage & I got elevated moisture reading of 97.4.

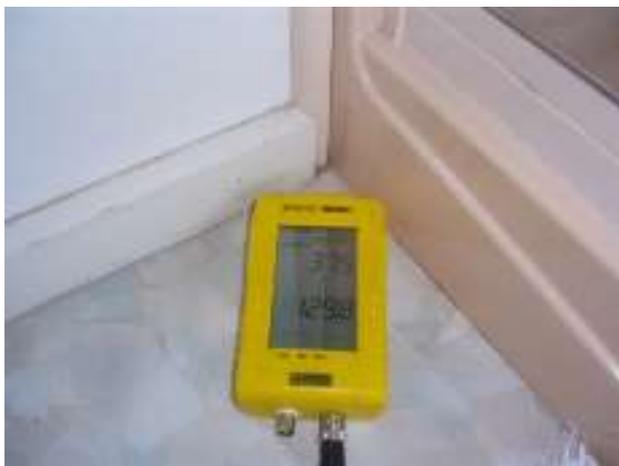
29. The LHS of the same shower unit. I received a reading of 129.8.

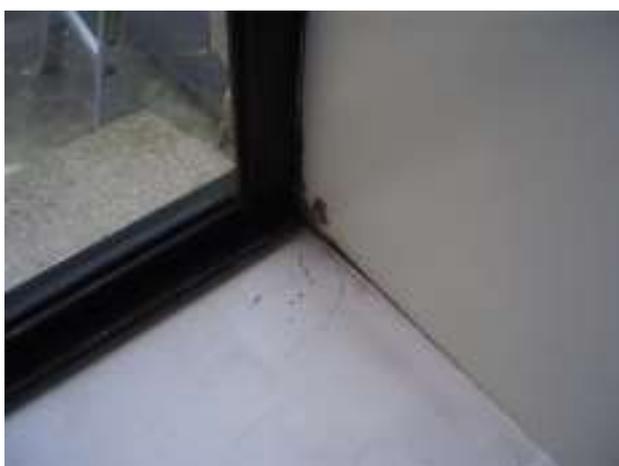
30. In the nursery the window sill liner has been recently replaced & on the lower portion of the jamb liner I got an elevated reading of 70.

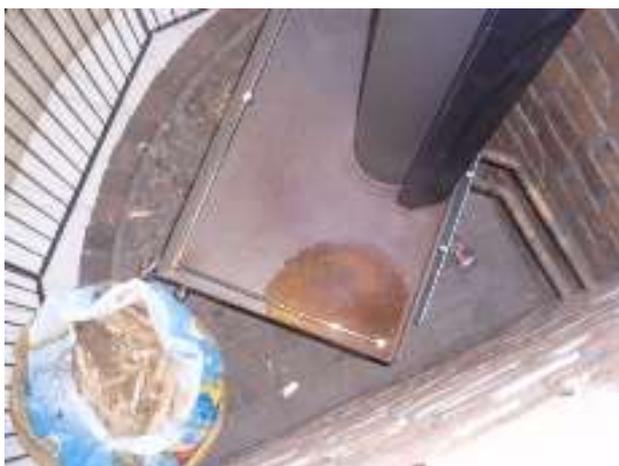
31. The flue leaks & has caused this rust stain on the top of the fire place.

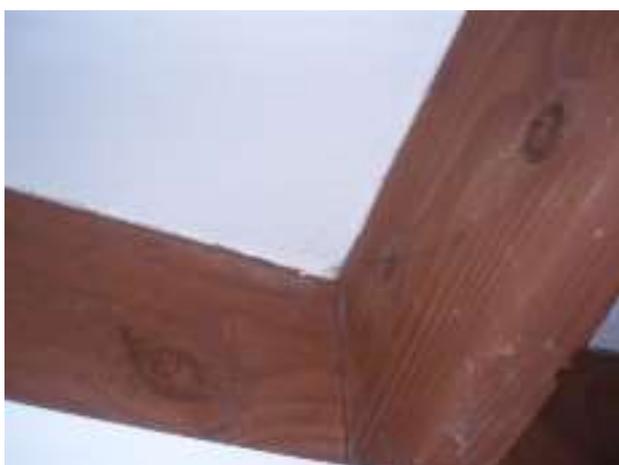
32. I got a slightly high moisture reading & the particle board ceiling in the bathroom is "blown" near the eaves. This is below the bottom of the valley of the covered carport / entrance way so I suspect there is a small roof leak here. Also there is a section of repaired ceiling here so this has been a trouble spot in the past.

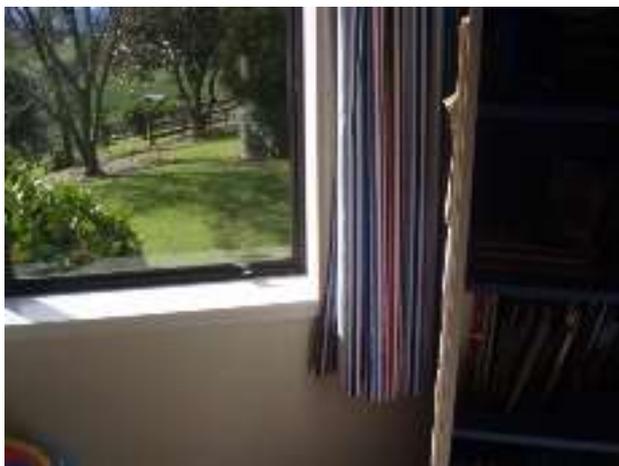
33. This is Flynn's bedroom on the NE side of the house. The window liners have been recently replaced here also.

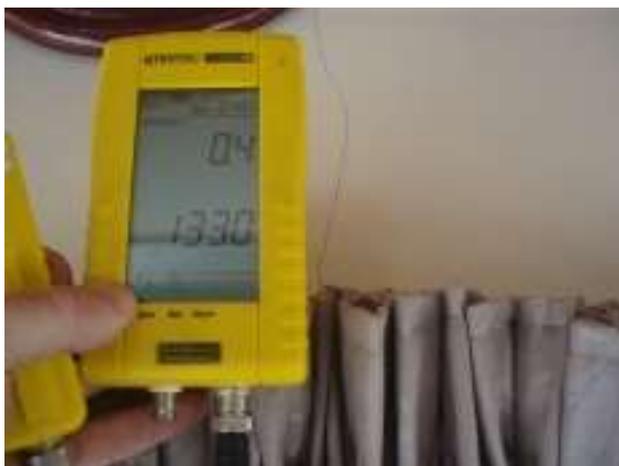
34. On the North wall of the lounge there is a significant crack visible in the wall lining. It runs from the top of the window up to the bottom of the high gable window above. All along the bottom of the gable window I received high moisture readings. They were highest closer to the apex & got progressively lower as I moved to the right. This area obviously leaks badly. The moisture meter shows a reading of 133.

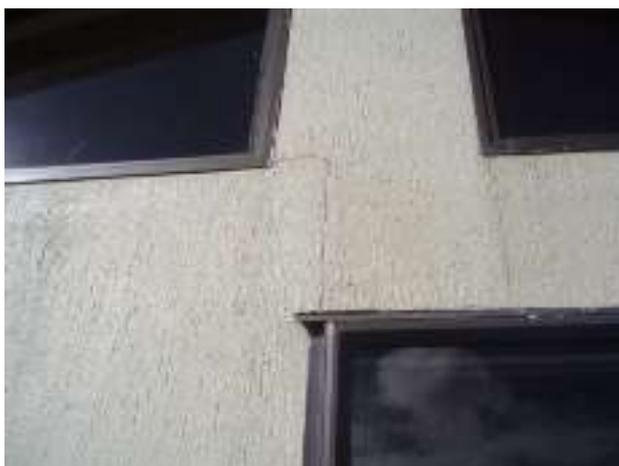
35. This is the exterior of the above location & the crack in the wall board is mirrored in the exterior cladding. The fin of the aluminium joinery is partially buried in the texture coating.

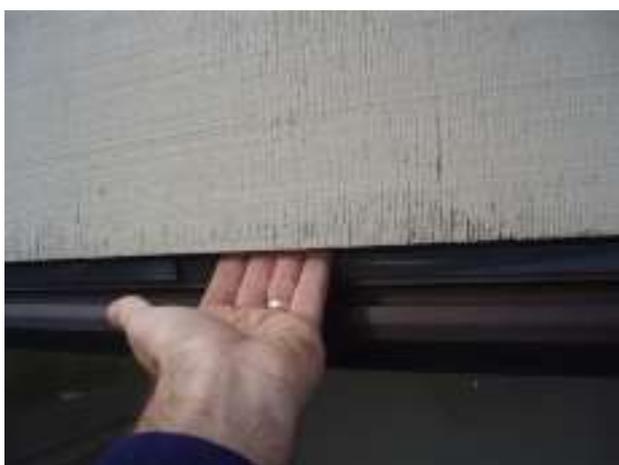
36. This is the plywood cladding above the high kitchen windows. It is bowed out & I was able to insert my fingers under it. The cladding here is not to a high standard & requires maintenance.

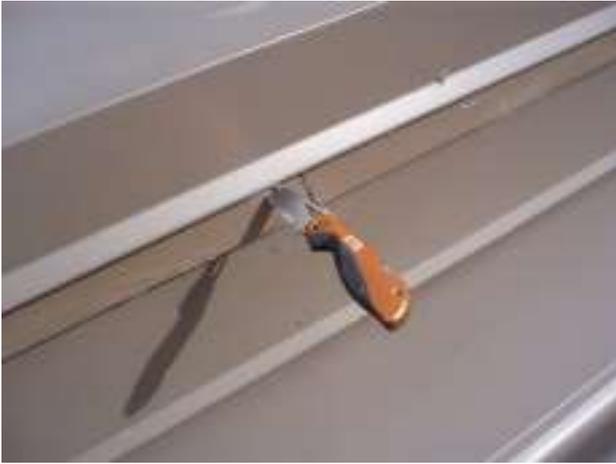
37. The fascia board where the garage roof steps up by the master bedroom is decayed & I was able to push my pocket knife into it.

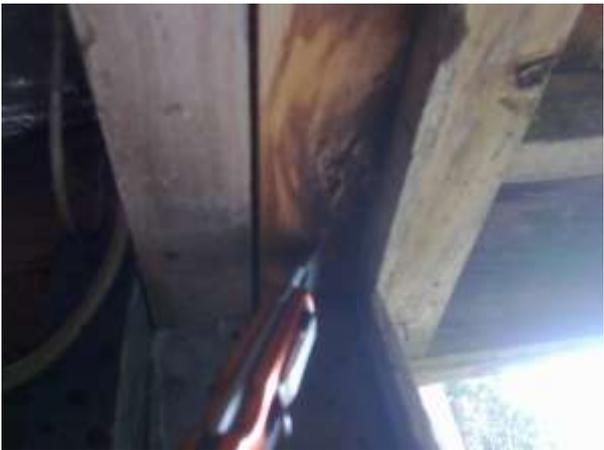
38. The sub floor space.
This is a wet & decayed boundary joist on the East wall of the building.

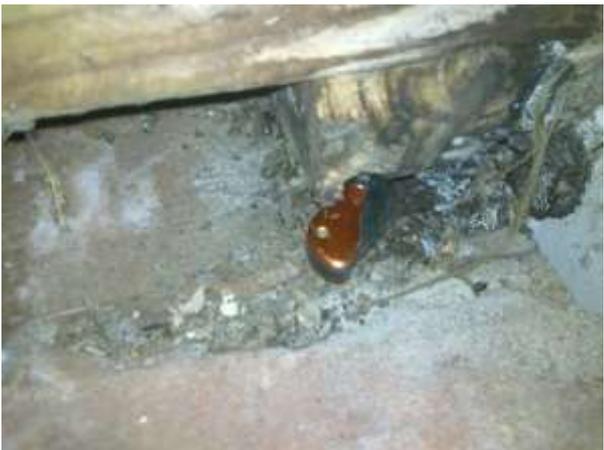
39. This is a severely decayed bearer which sits on top of a masonry foundation wall. I met no resistance at all when I pushed my knife into this.

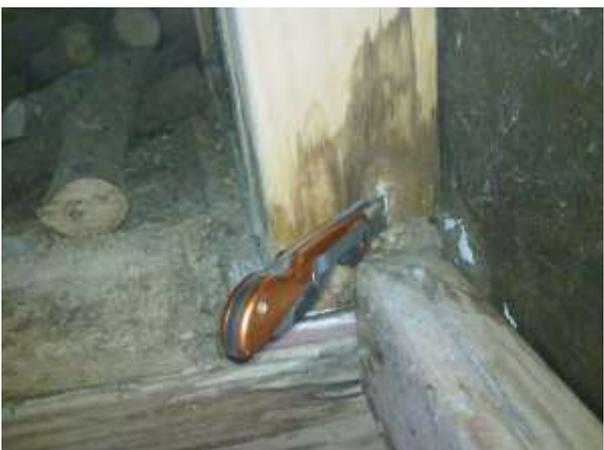
40. A badly decayed jack stud.
